TREE HEALTH

May 4, 2016

RE: Tree Inspection of 95 Birch Drive, East Hills, NY 11576

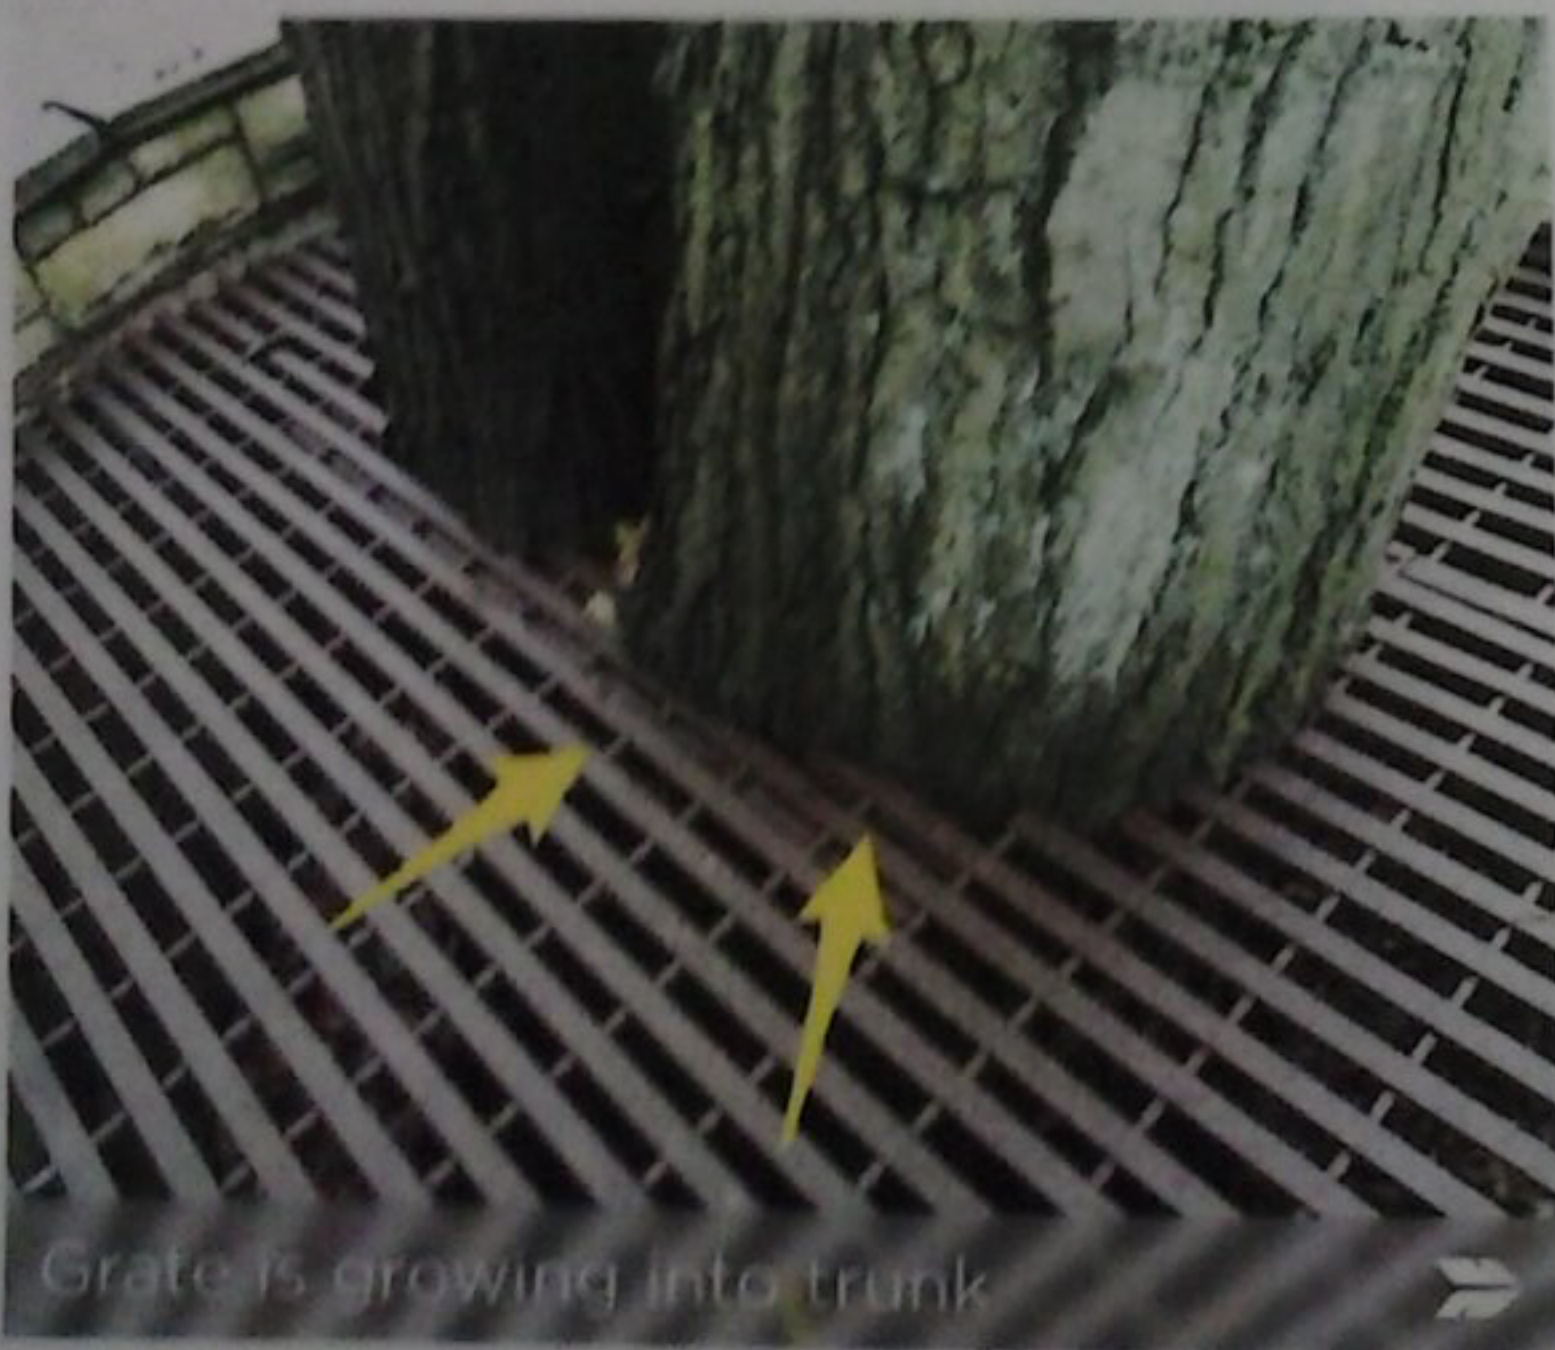
Unfortunately the grate of the well has now been engulfed by the trunk, the thin cable is performing little function and there is some trunk decay. The tree appears healthy and is leafing out normally. The homeowner expressed his fear of this tree failing.

Since there is a potential for this tree to fail and the risk to personal or property damage is great, this tree should be removed.

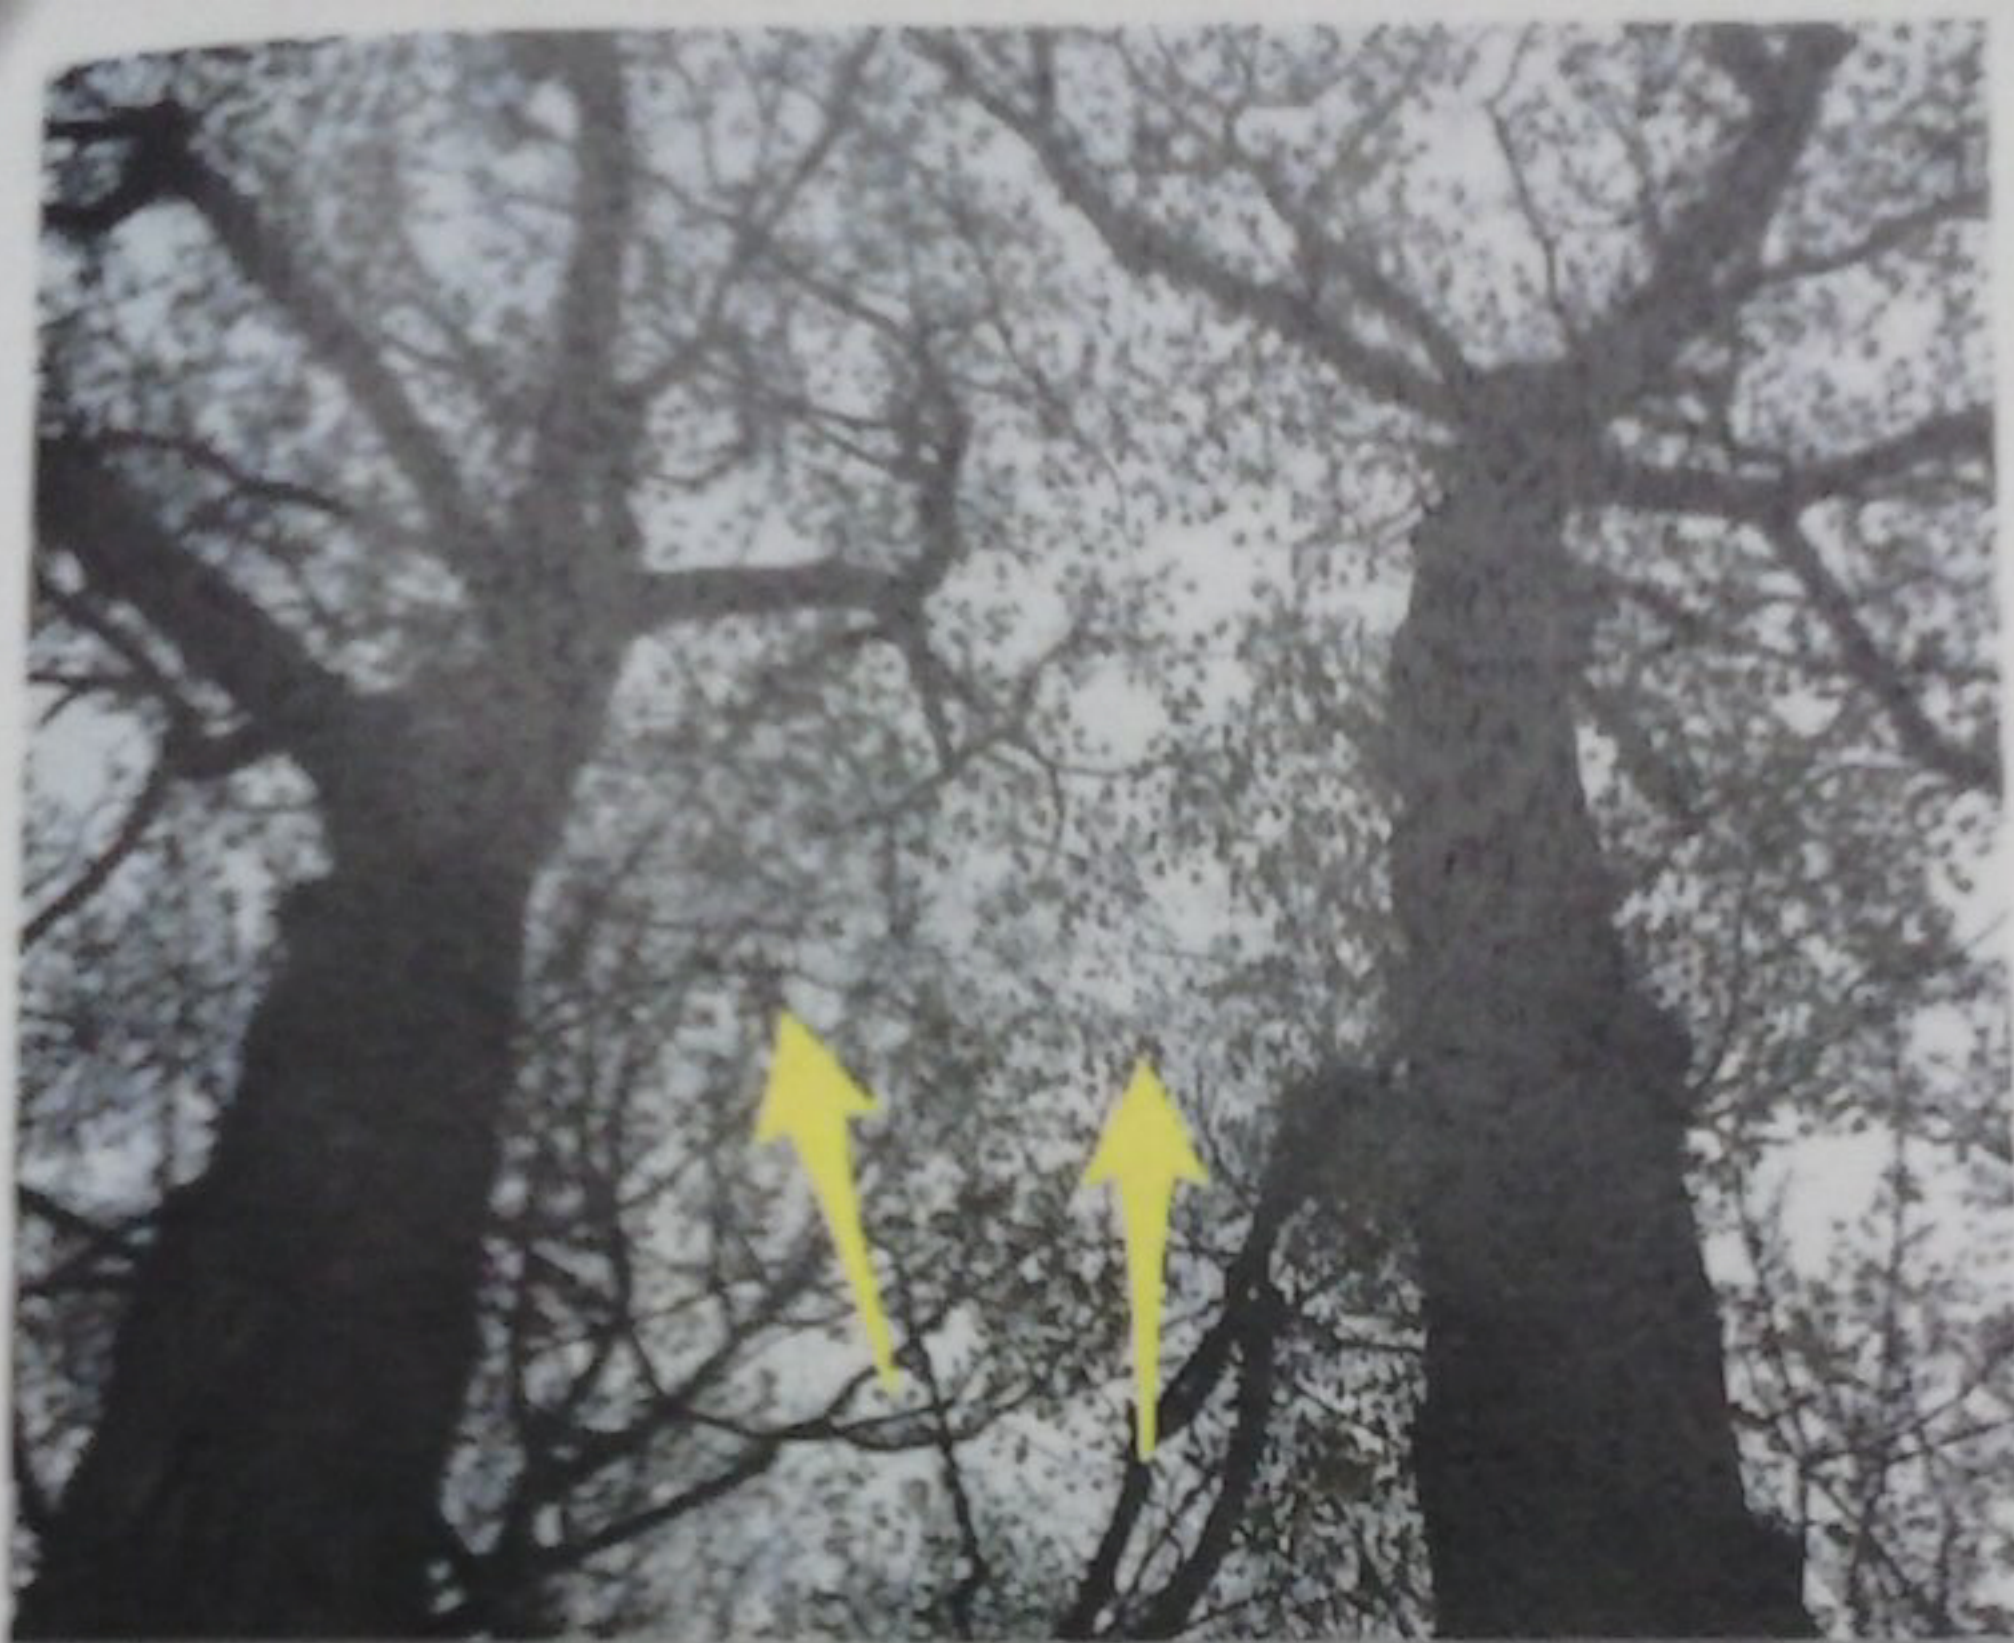
Cable is too thin

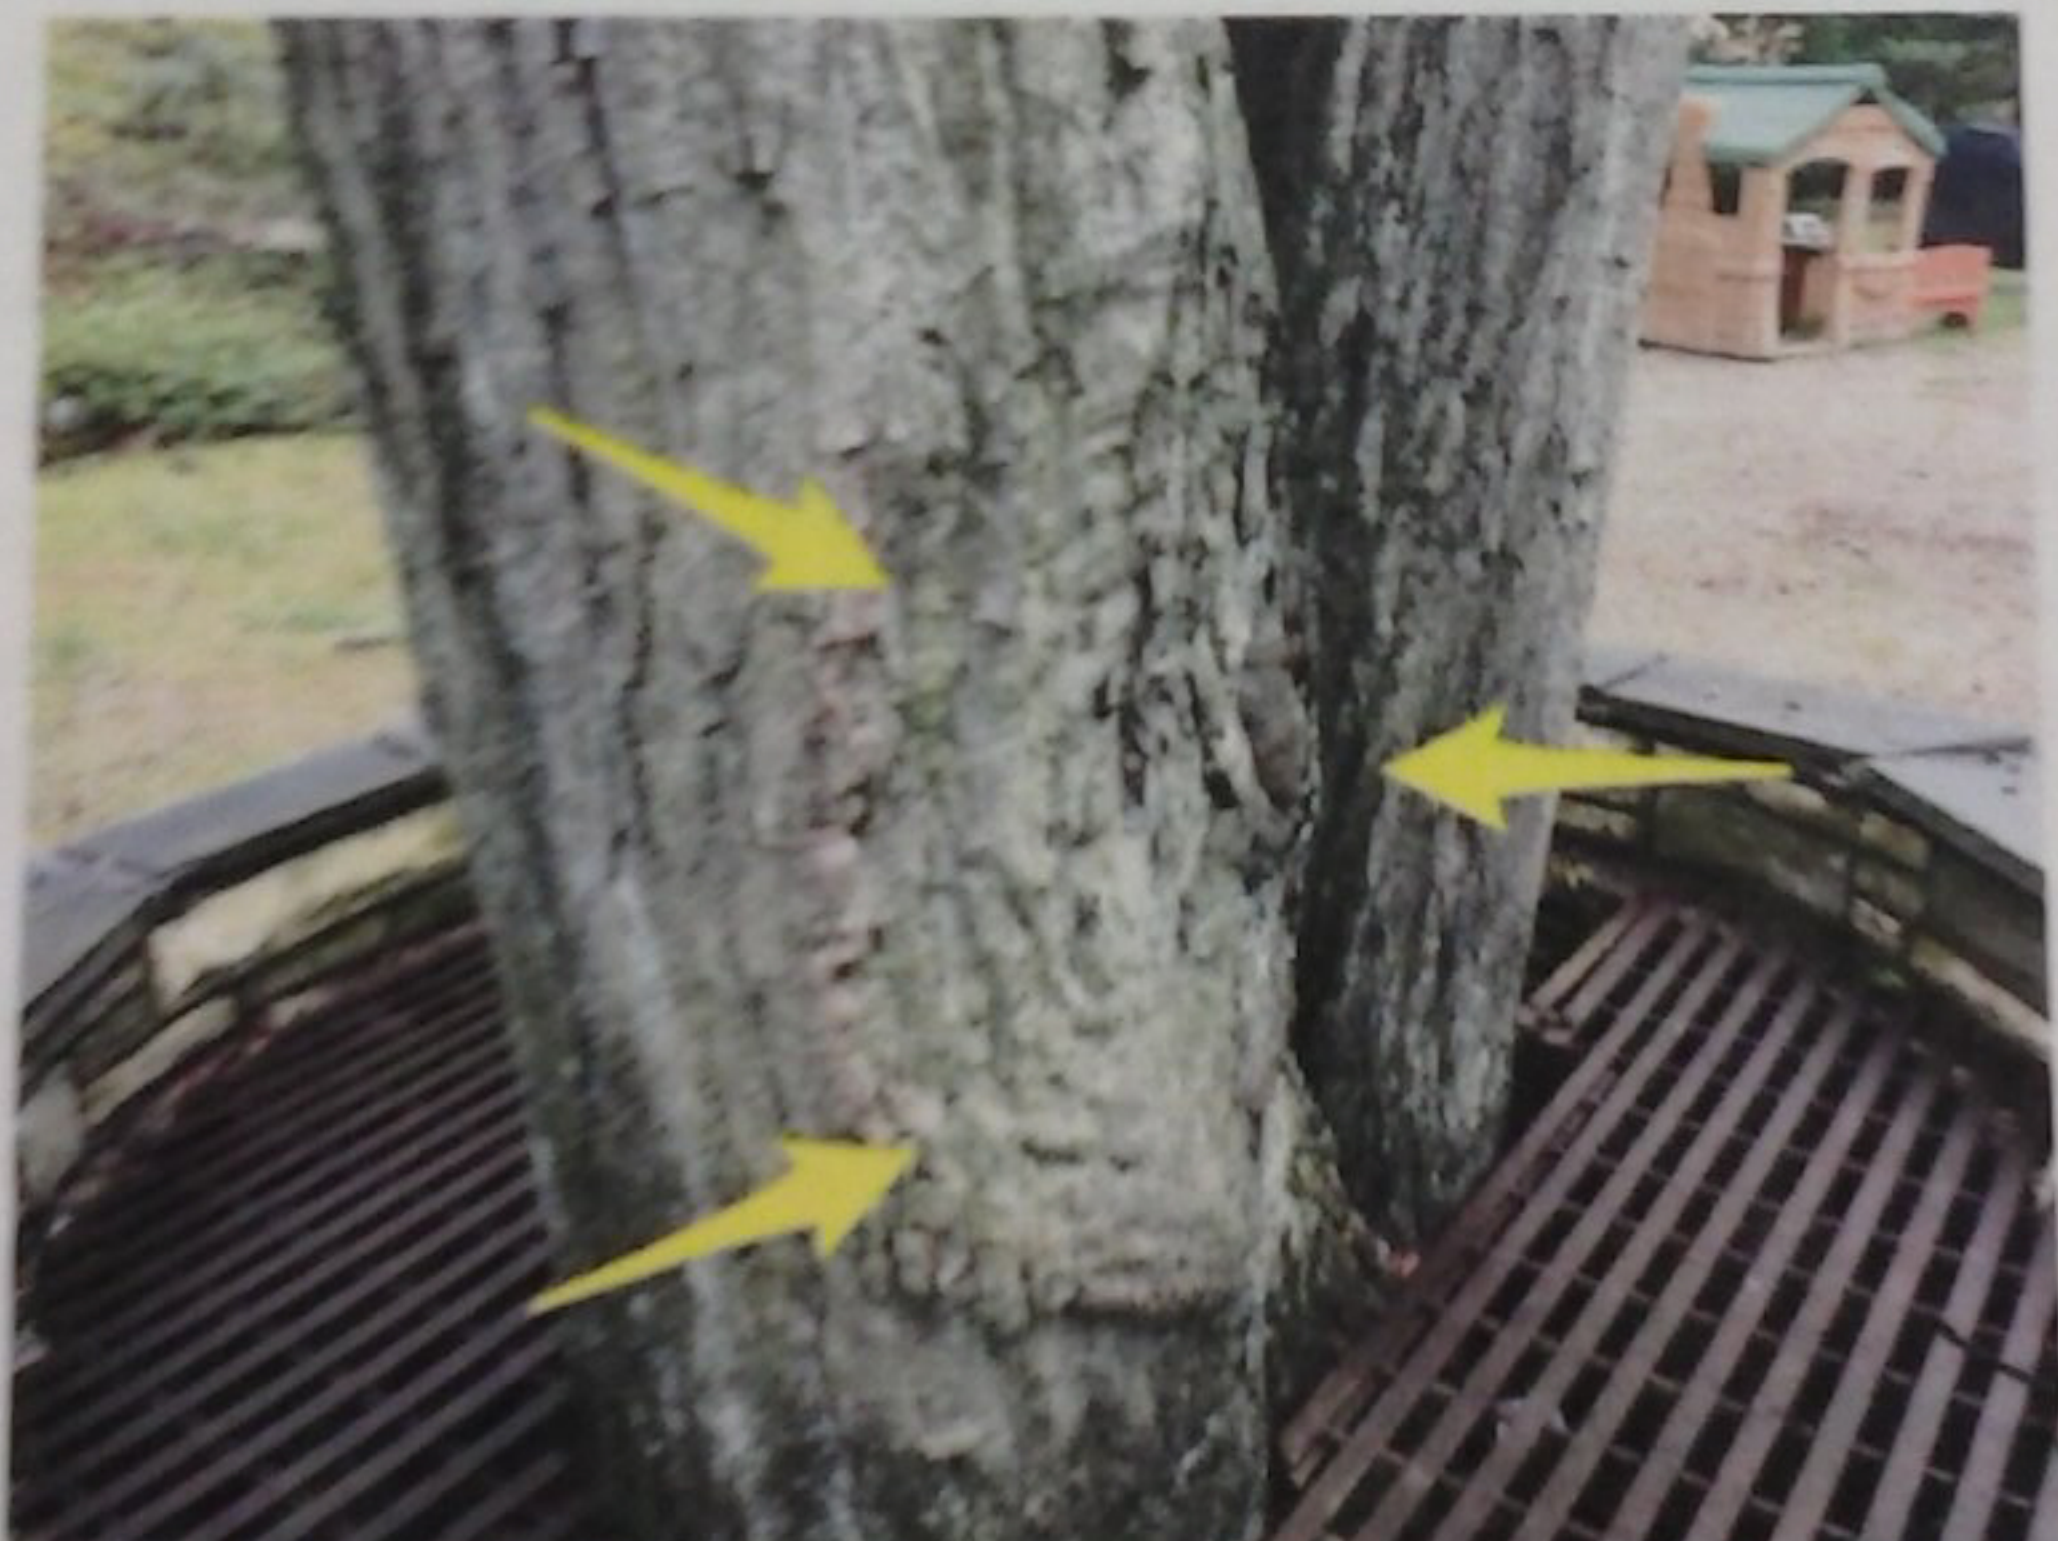
Abnormality in bark on large trunk
