TREE HEALTH

RE: Tree Inspection of 185 Elm Drive East Hills, NY 11576

**TREE REMOVAL/ALTERATION PERMIT
APPLICATION**

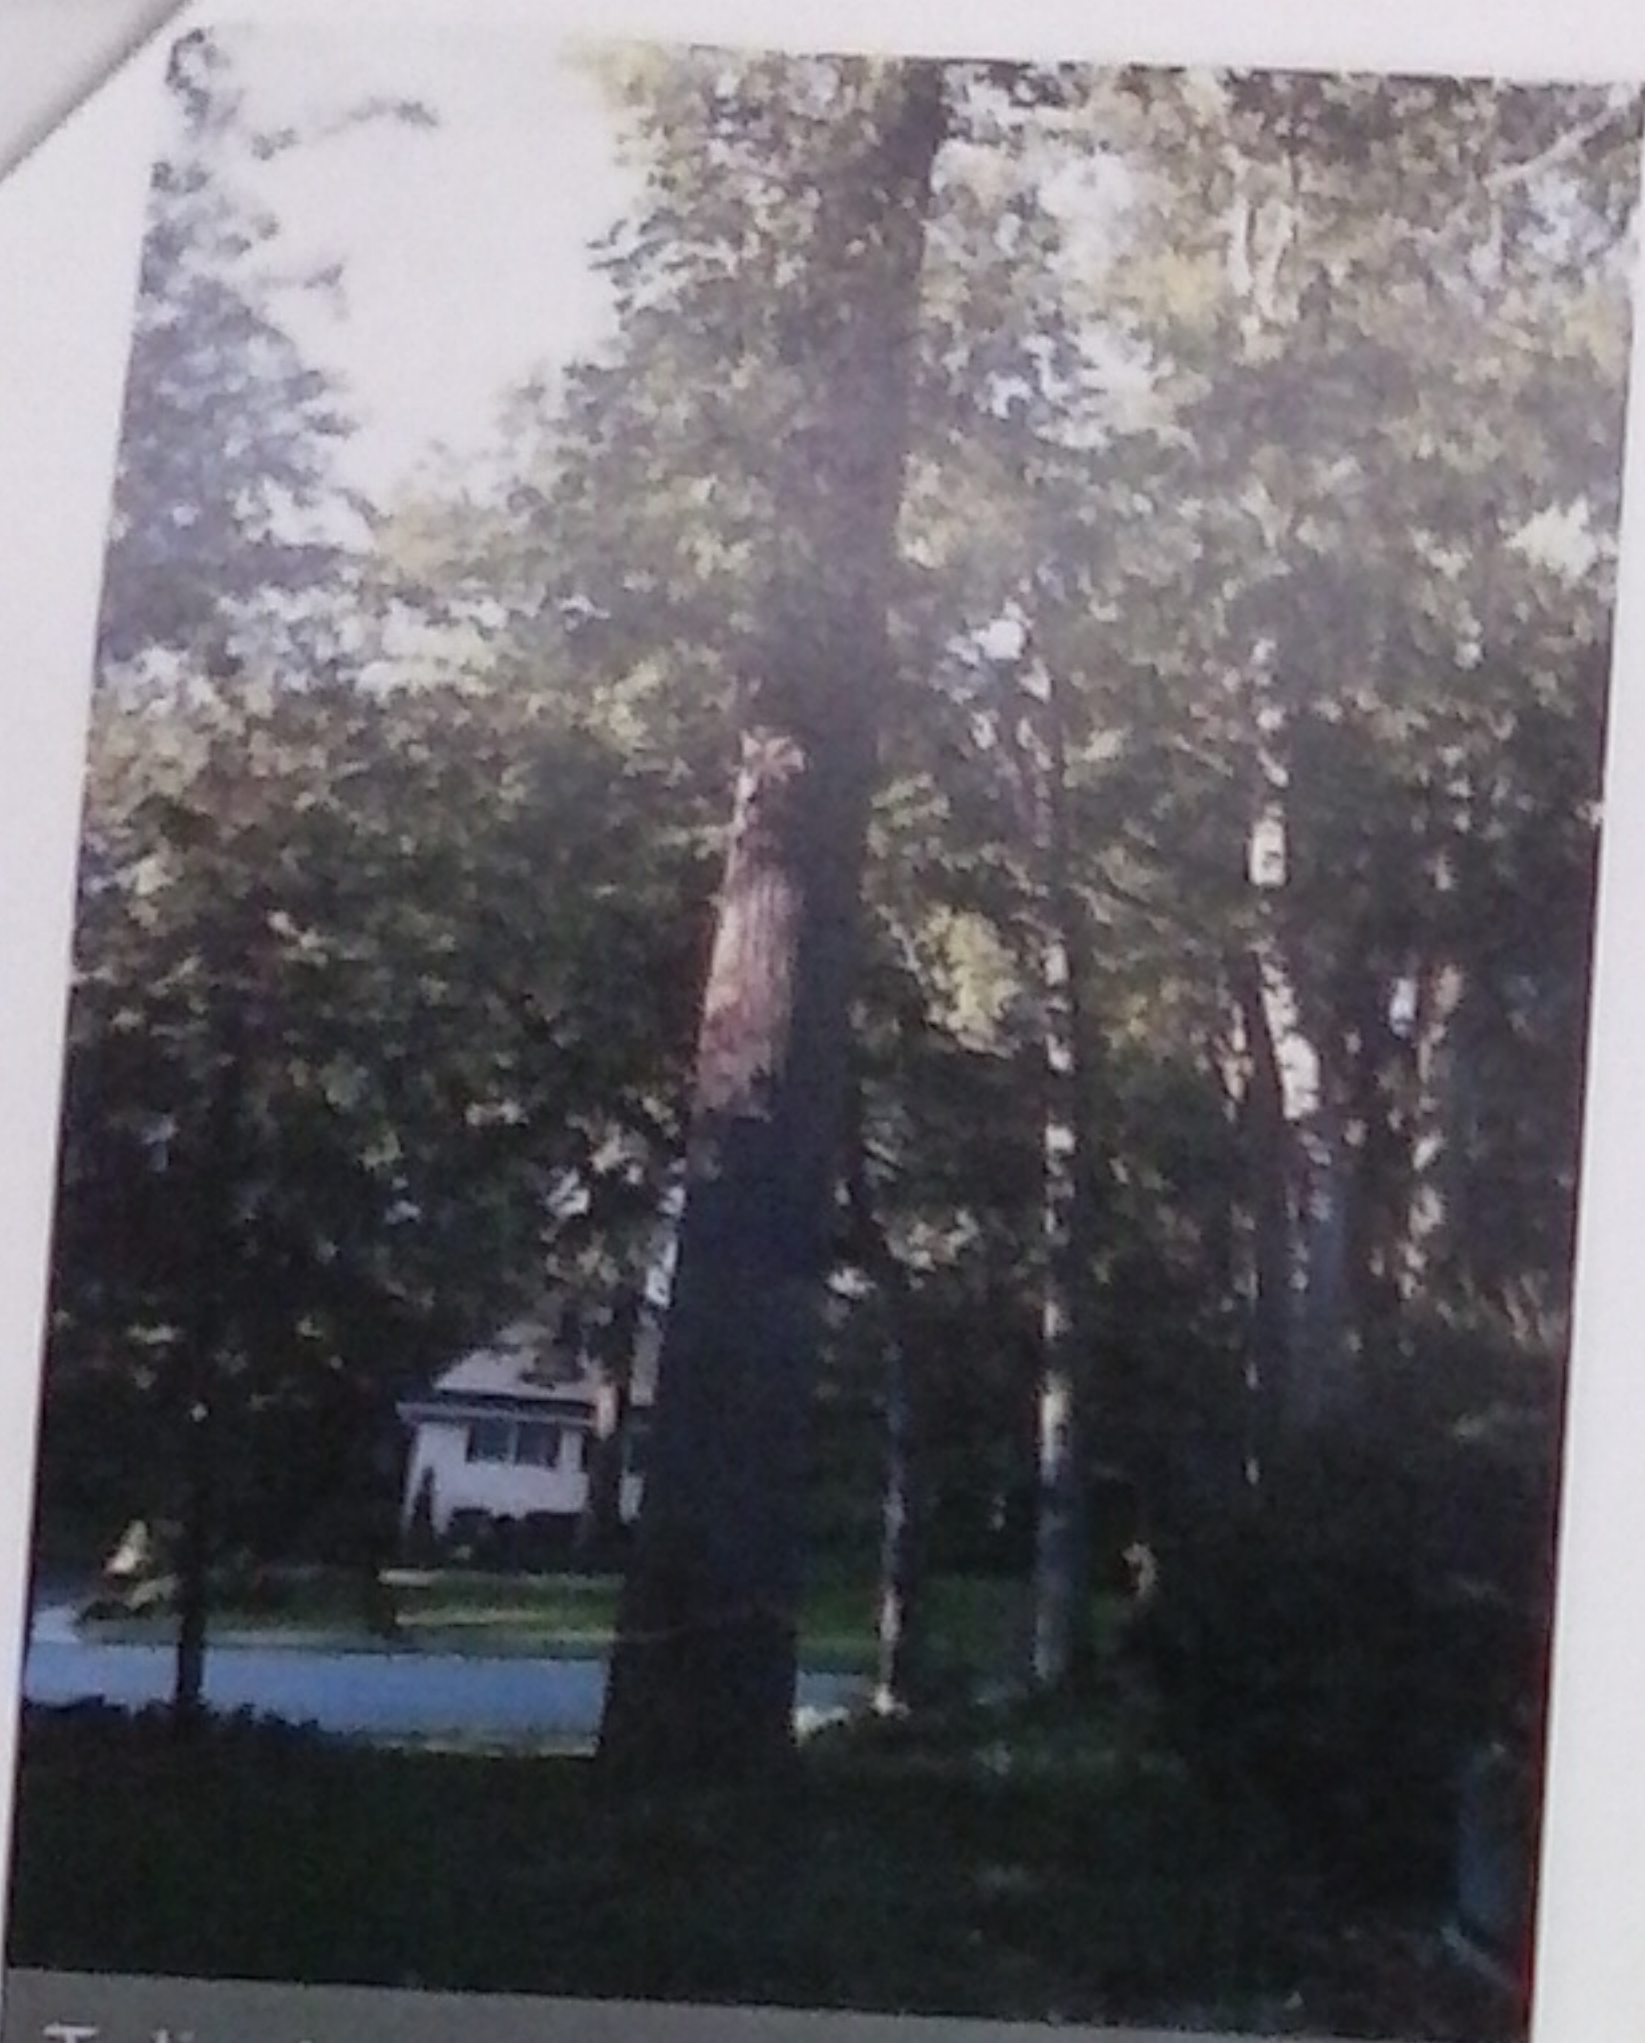
Tree number 11 is a large Tulip tree in great shape with a straight trunk.

Tulip tree 11 in great health ➤

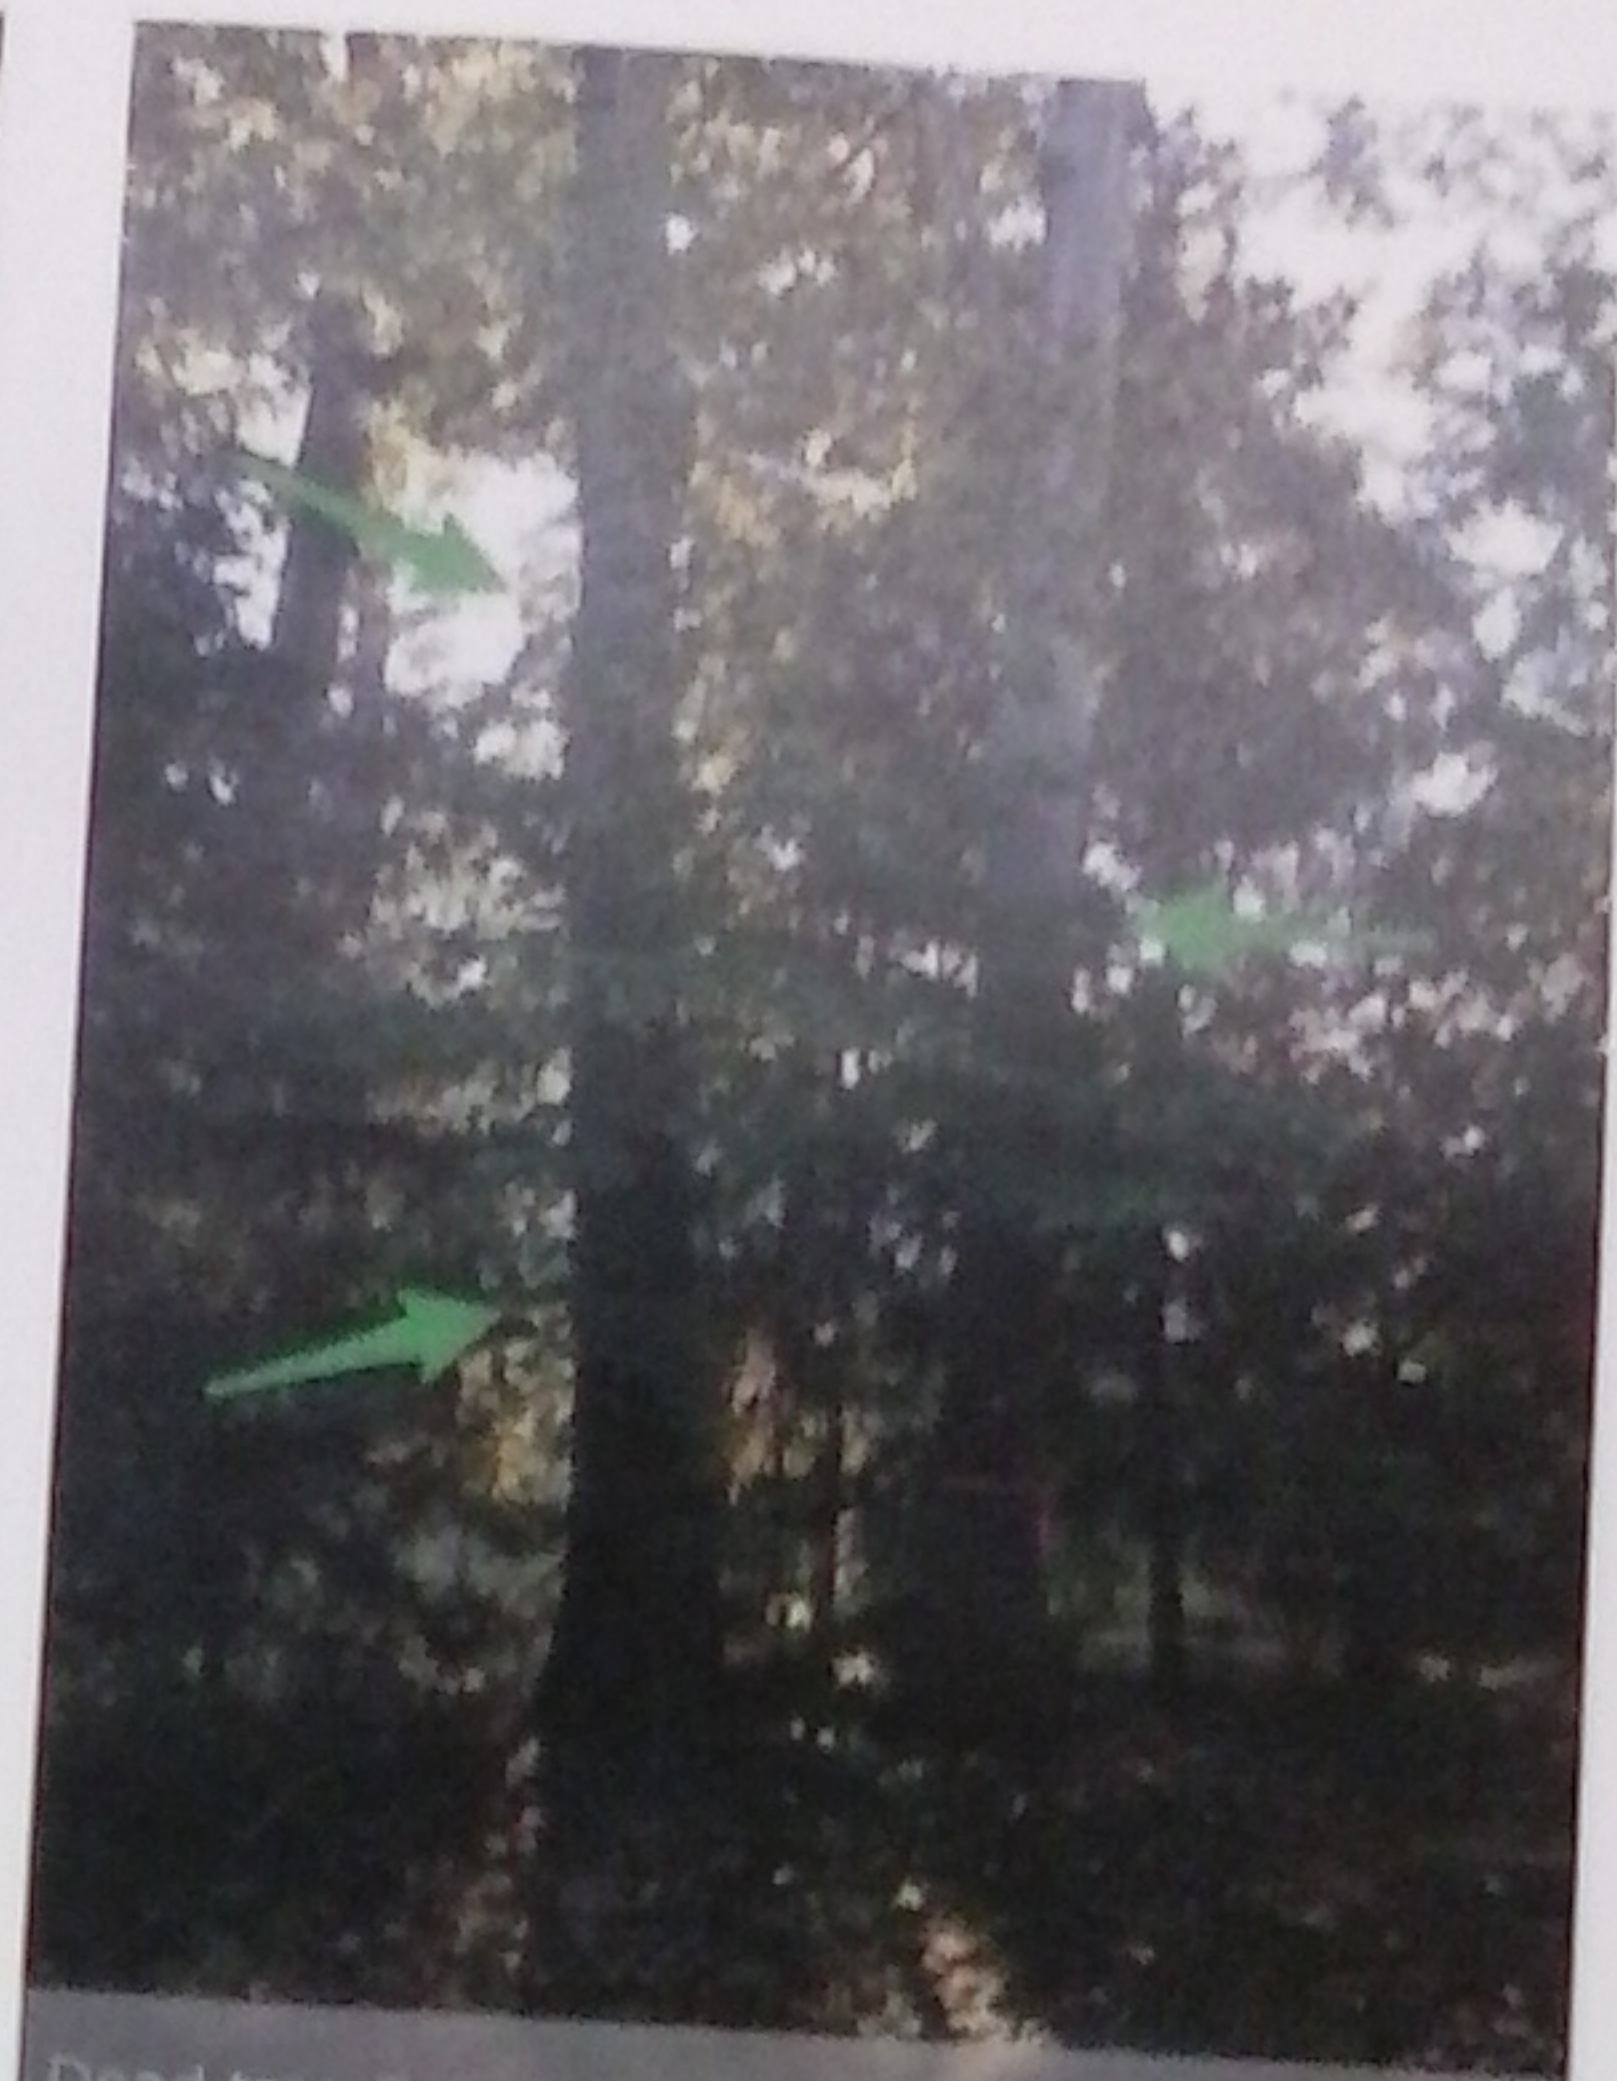
Tree number 6 is a dead Oak tree.

Tree number 7 is a Beech tree in poor shape with several trunk cavities.

Dead tree 6 on left. Tree 7 beech on right ➤

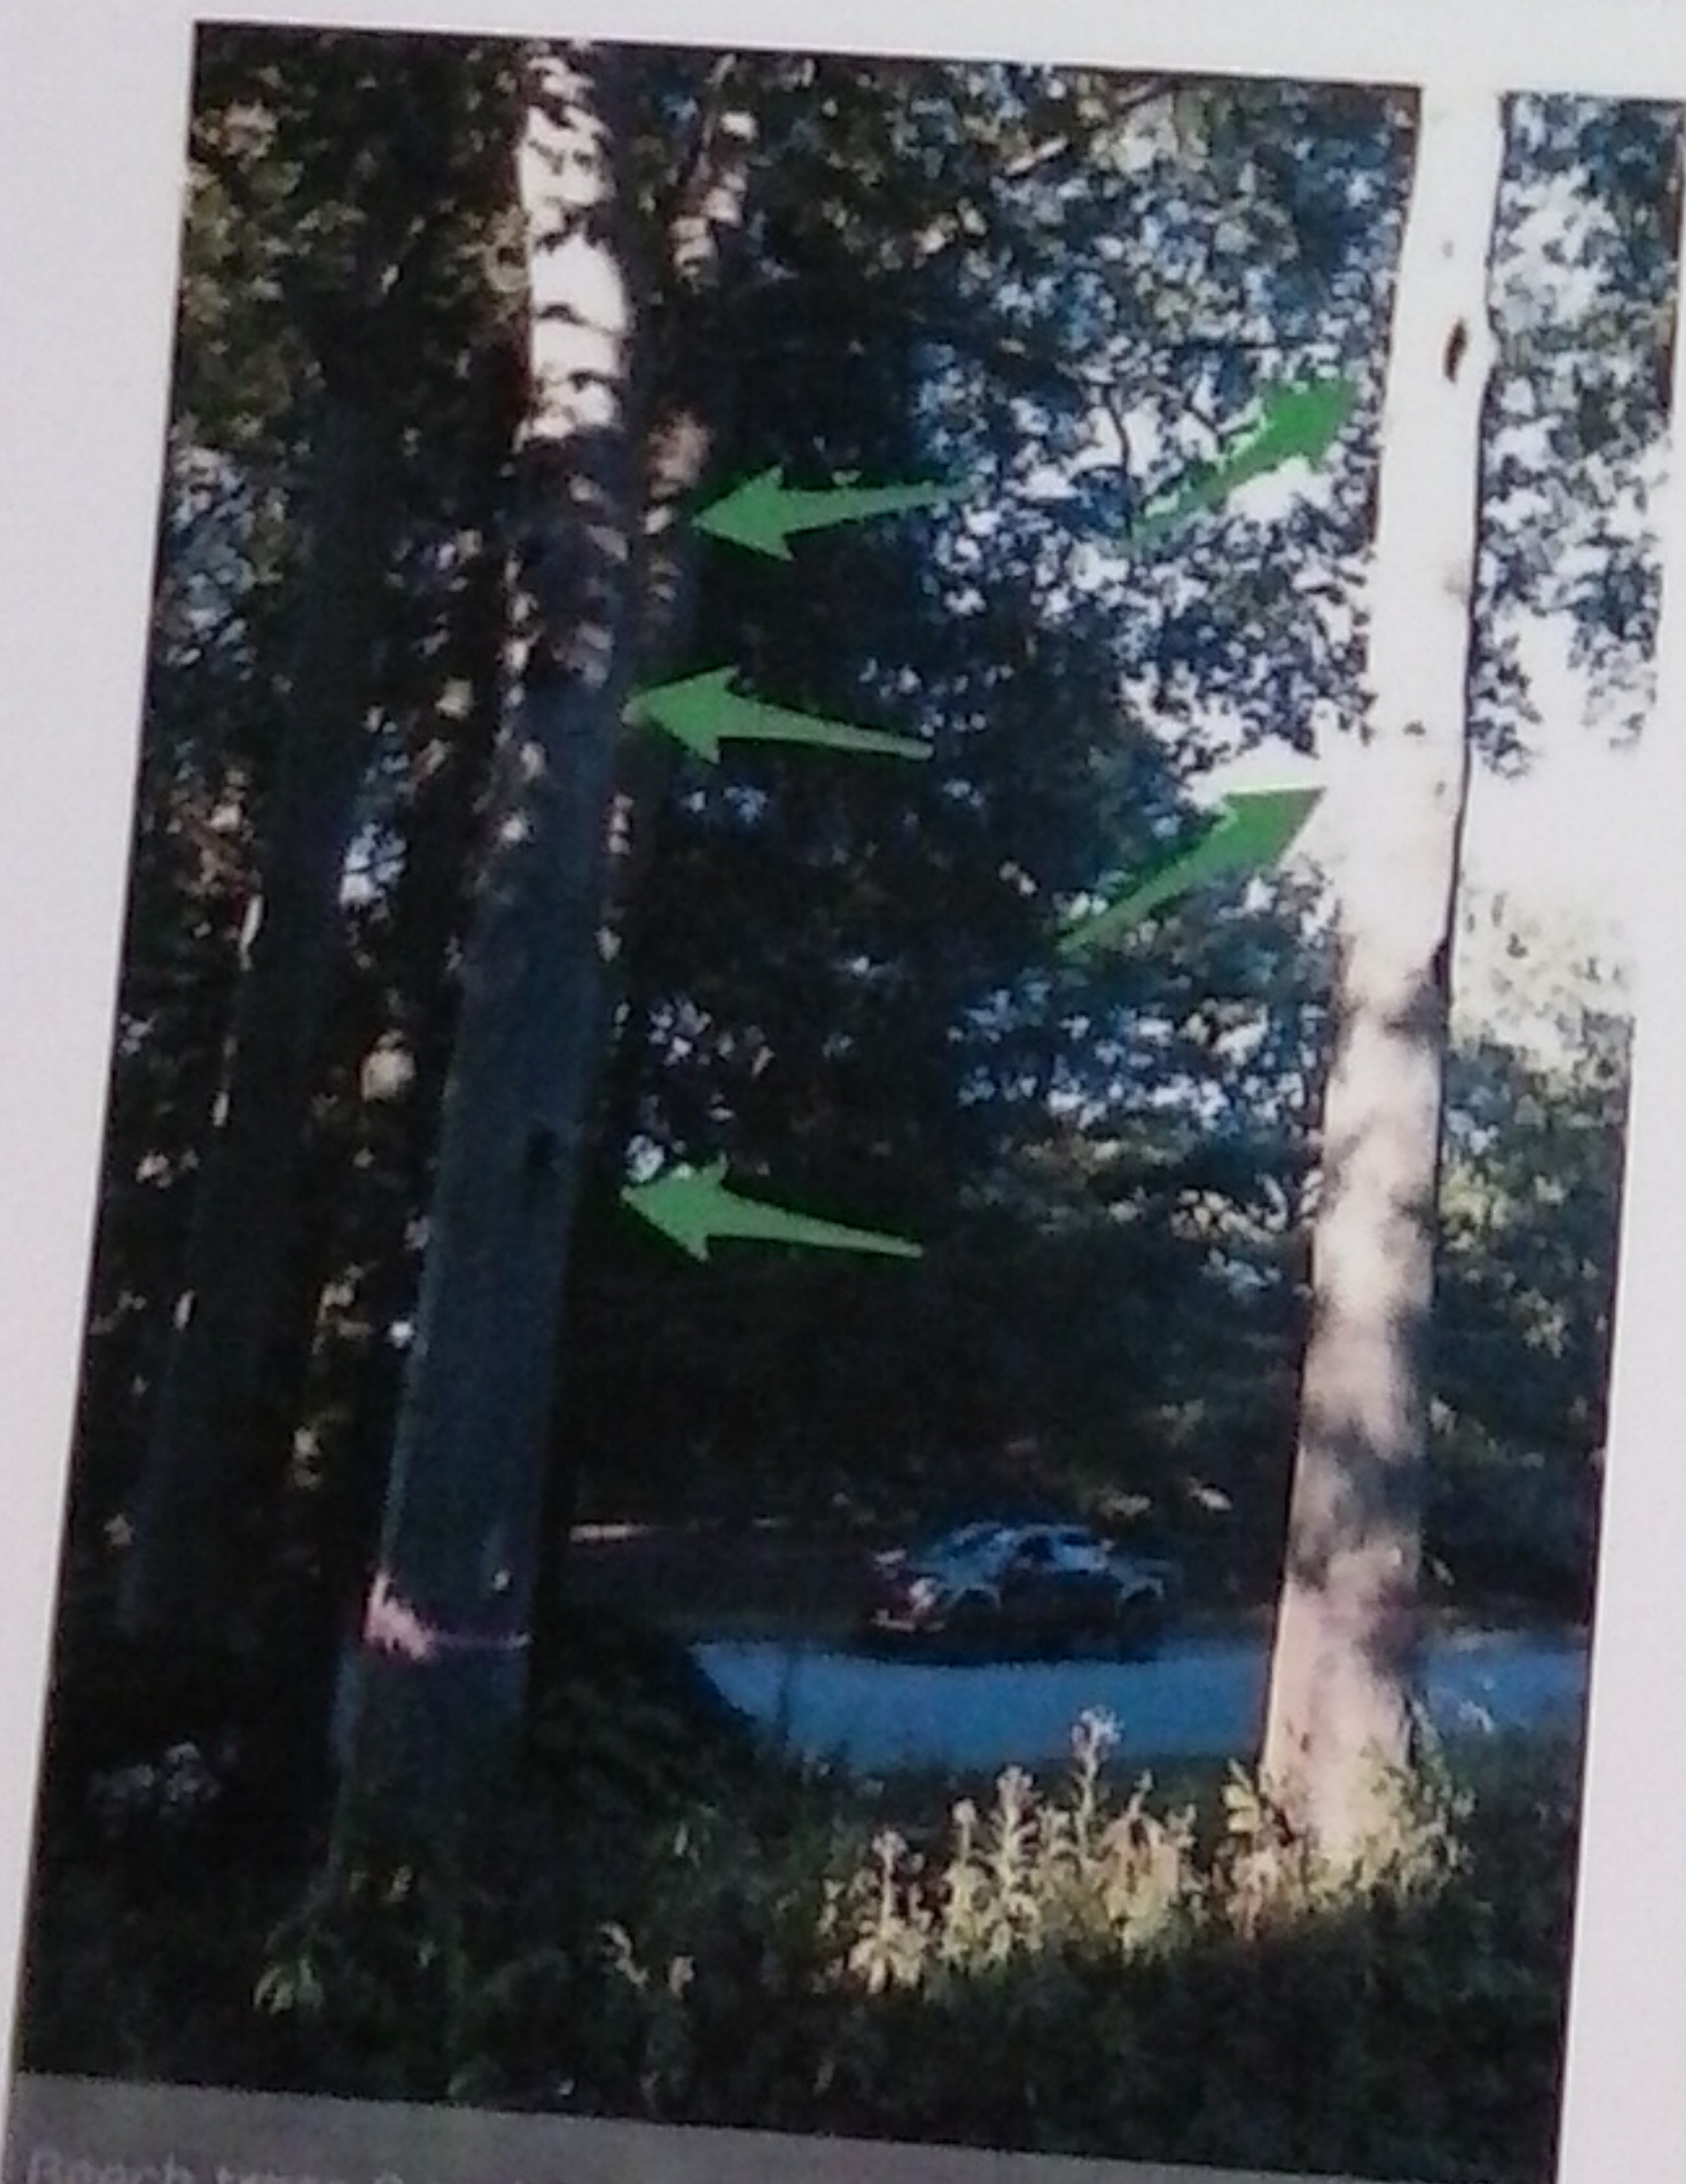
Tree number 8 is a Beech tree in poor shape with several trunk cavities.

Tree number 9 is a Beech tree in poor shape with several trunk cavities.

Beech trees 8 and 9 both riddled with cavities ➤

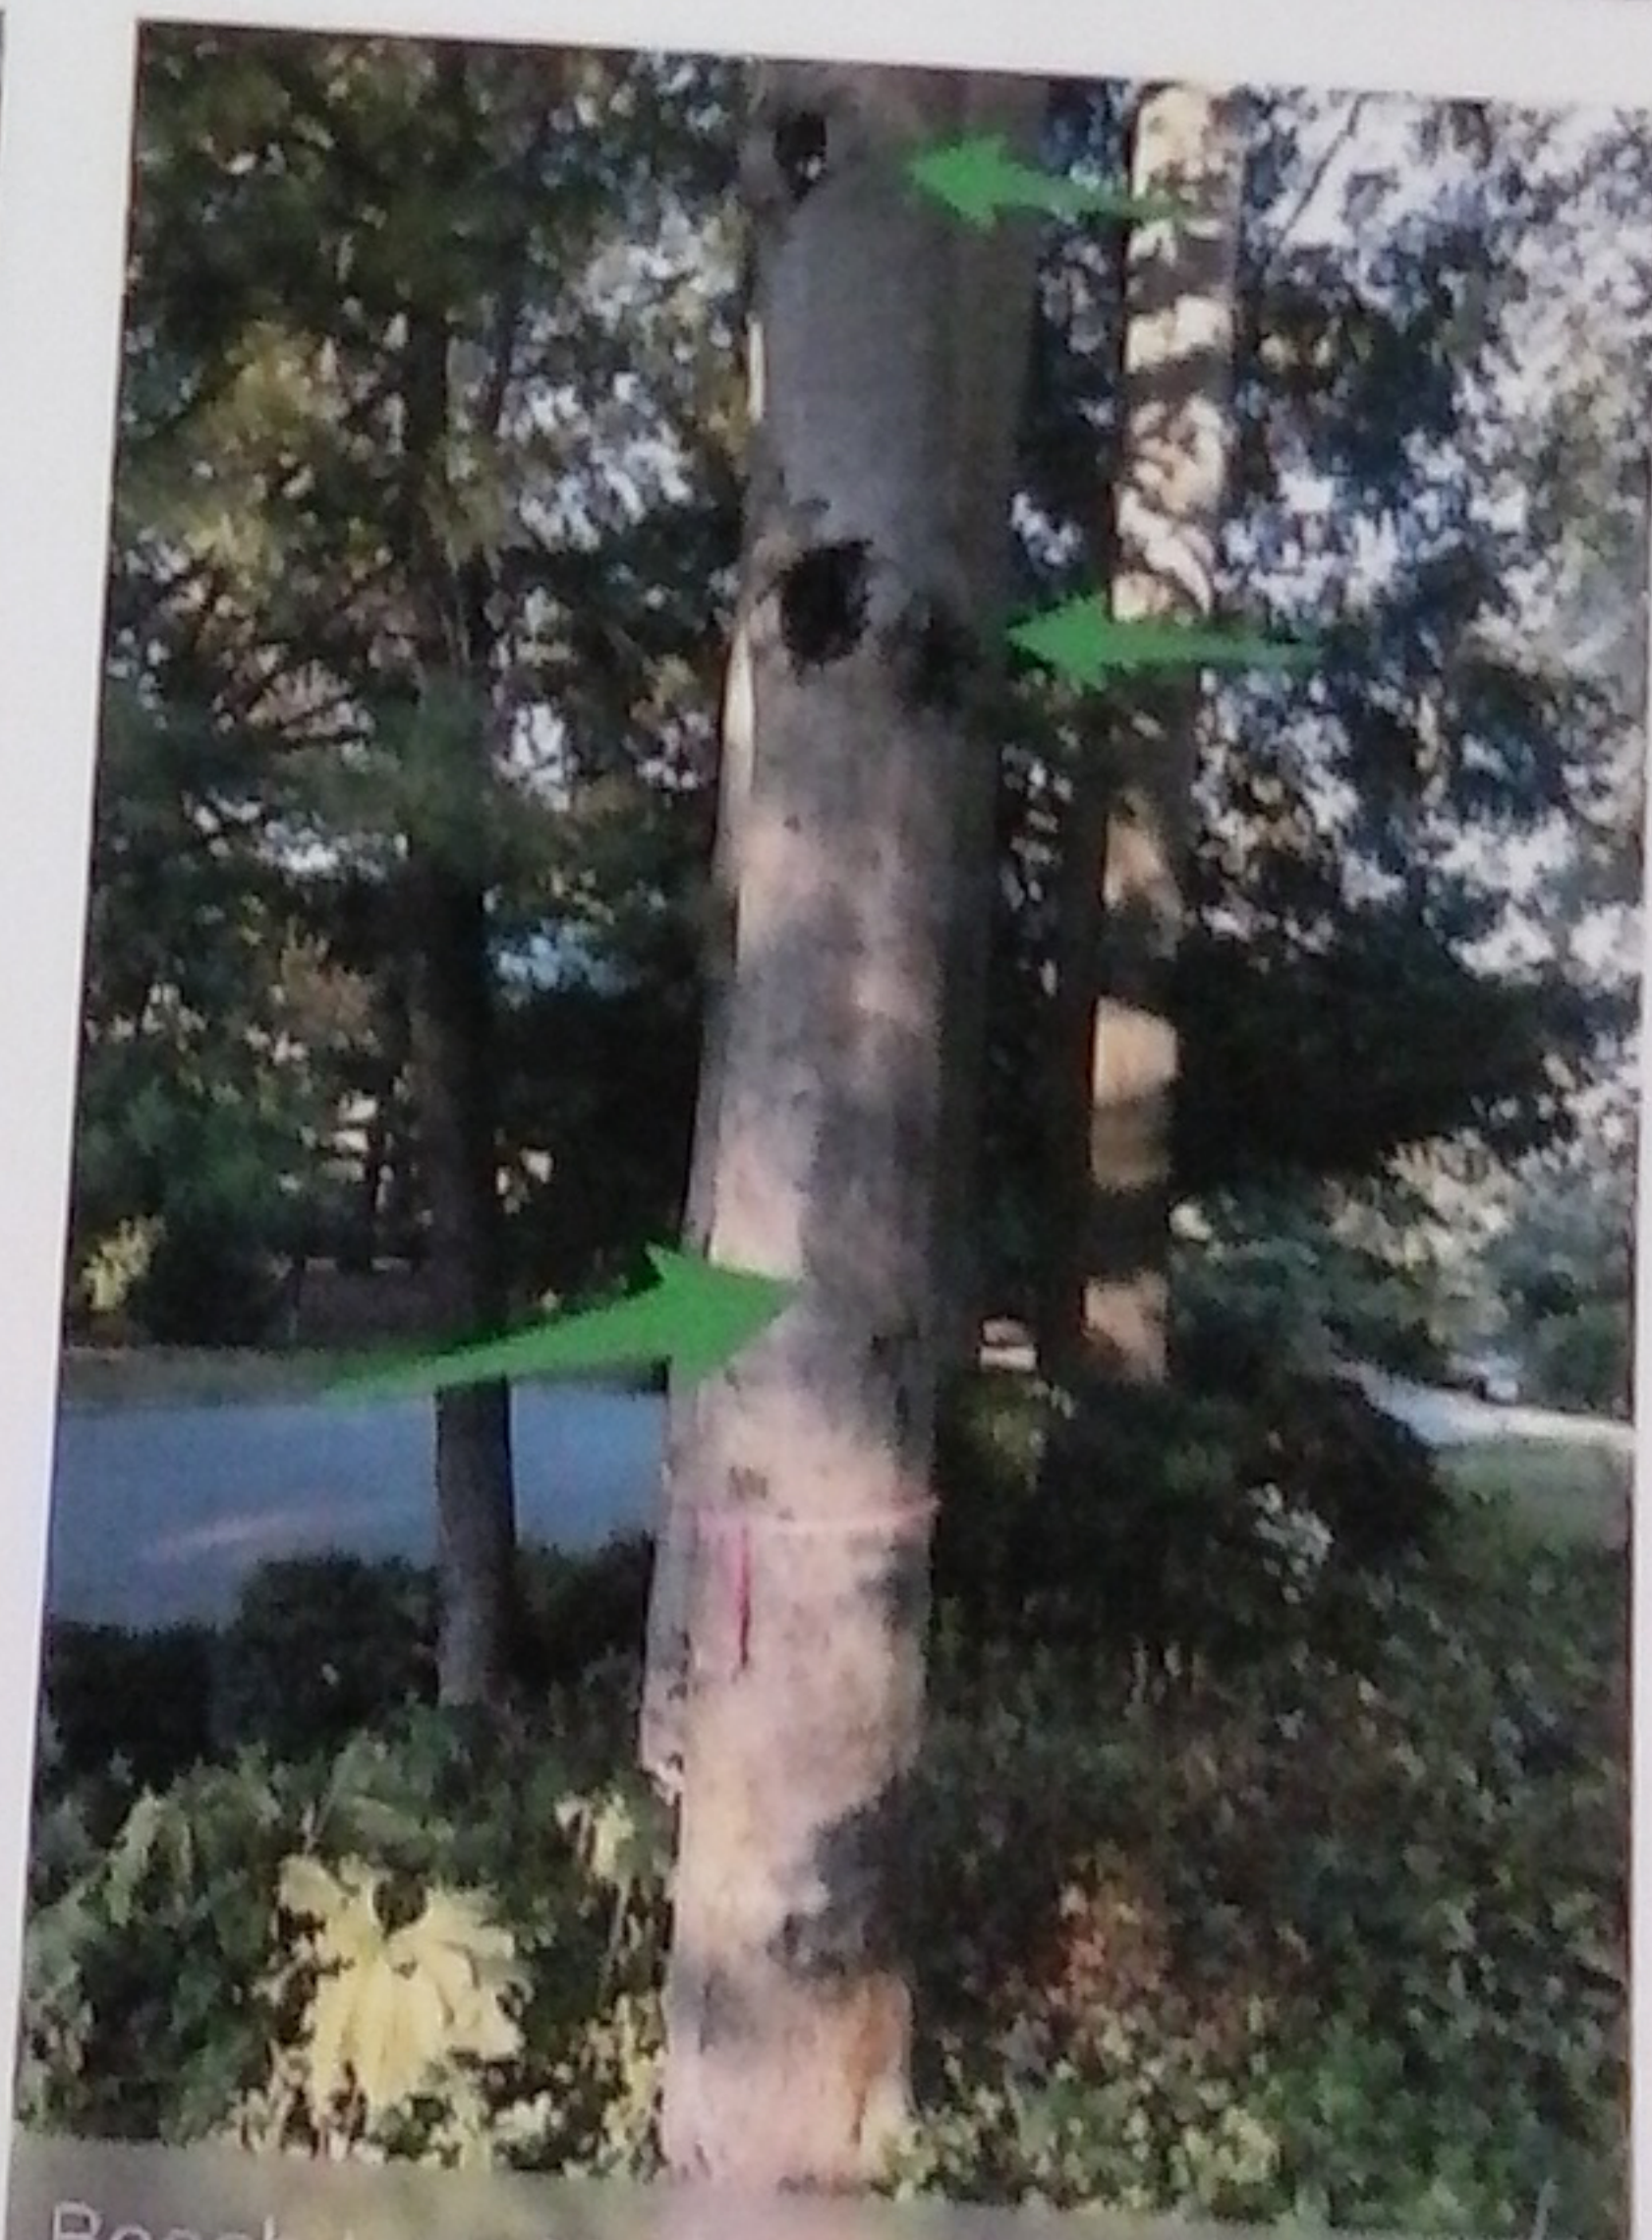
Tree number 10 is a Beech tree in poor shape with several trunk cavities.

Beech tree 10 big trunk cavities ➤

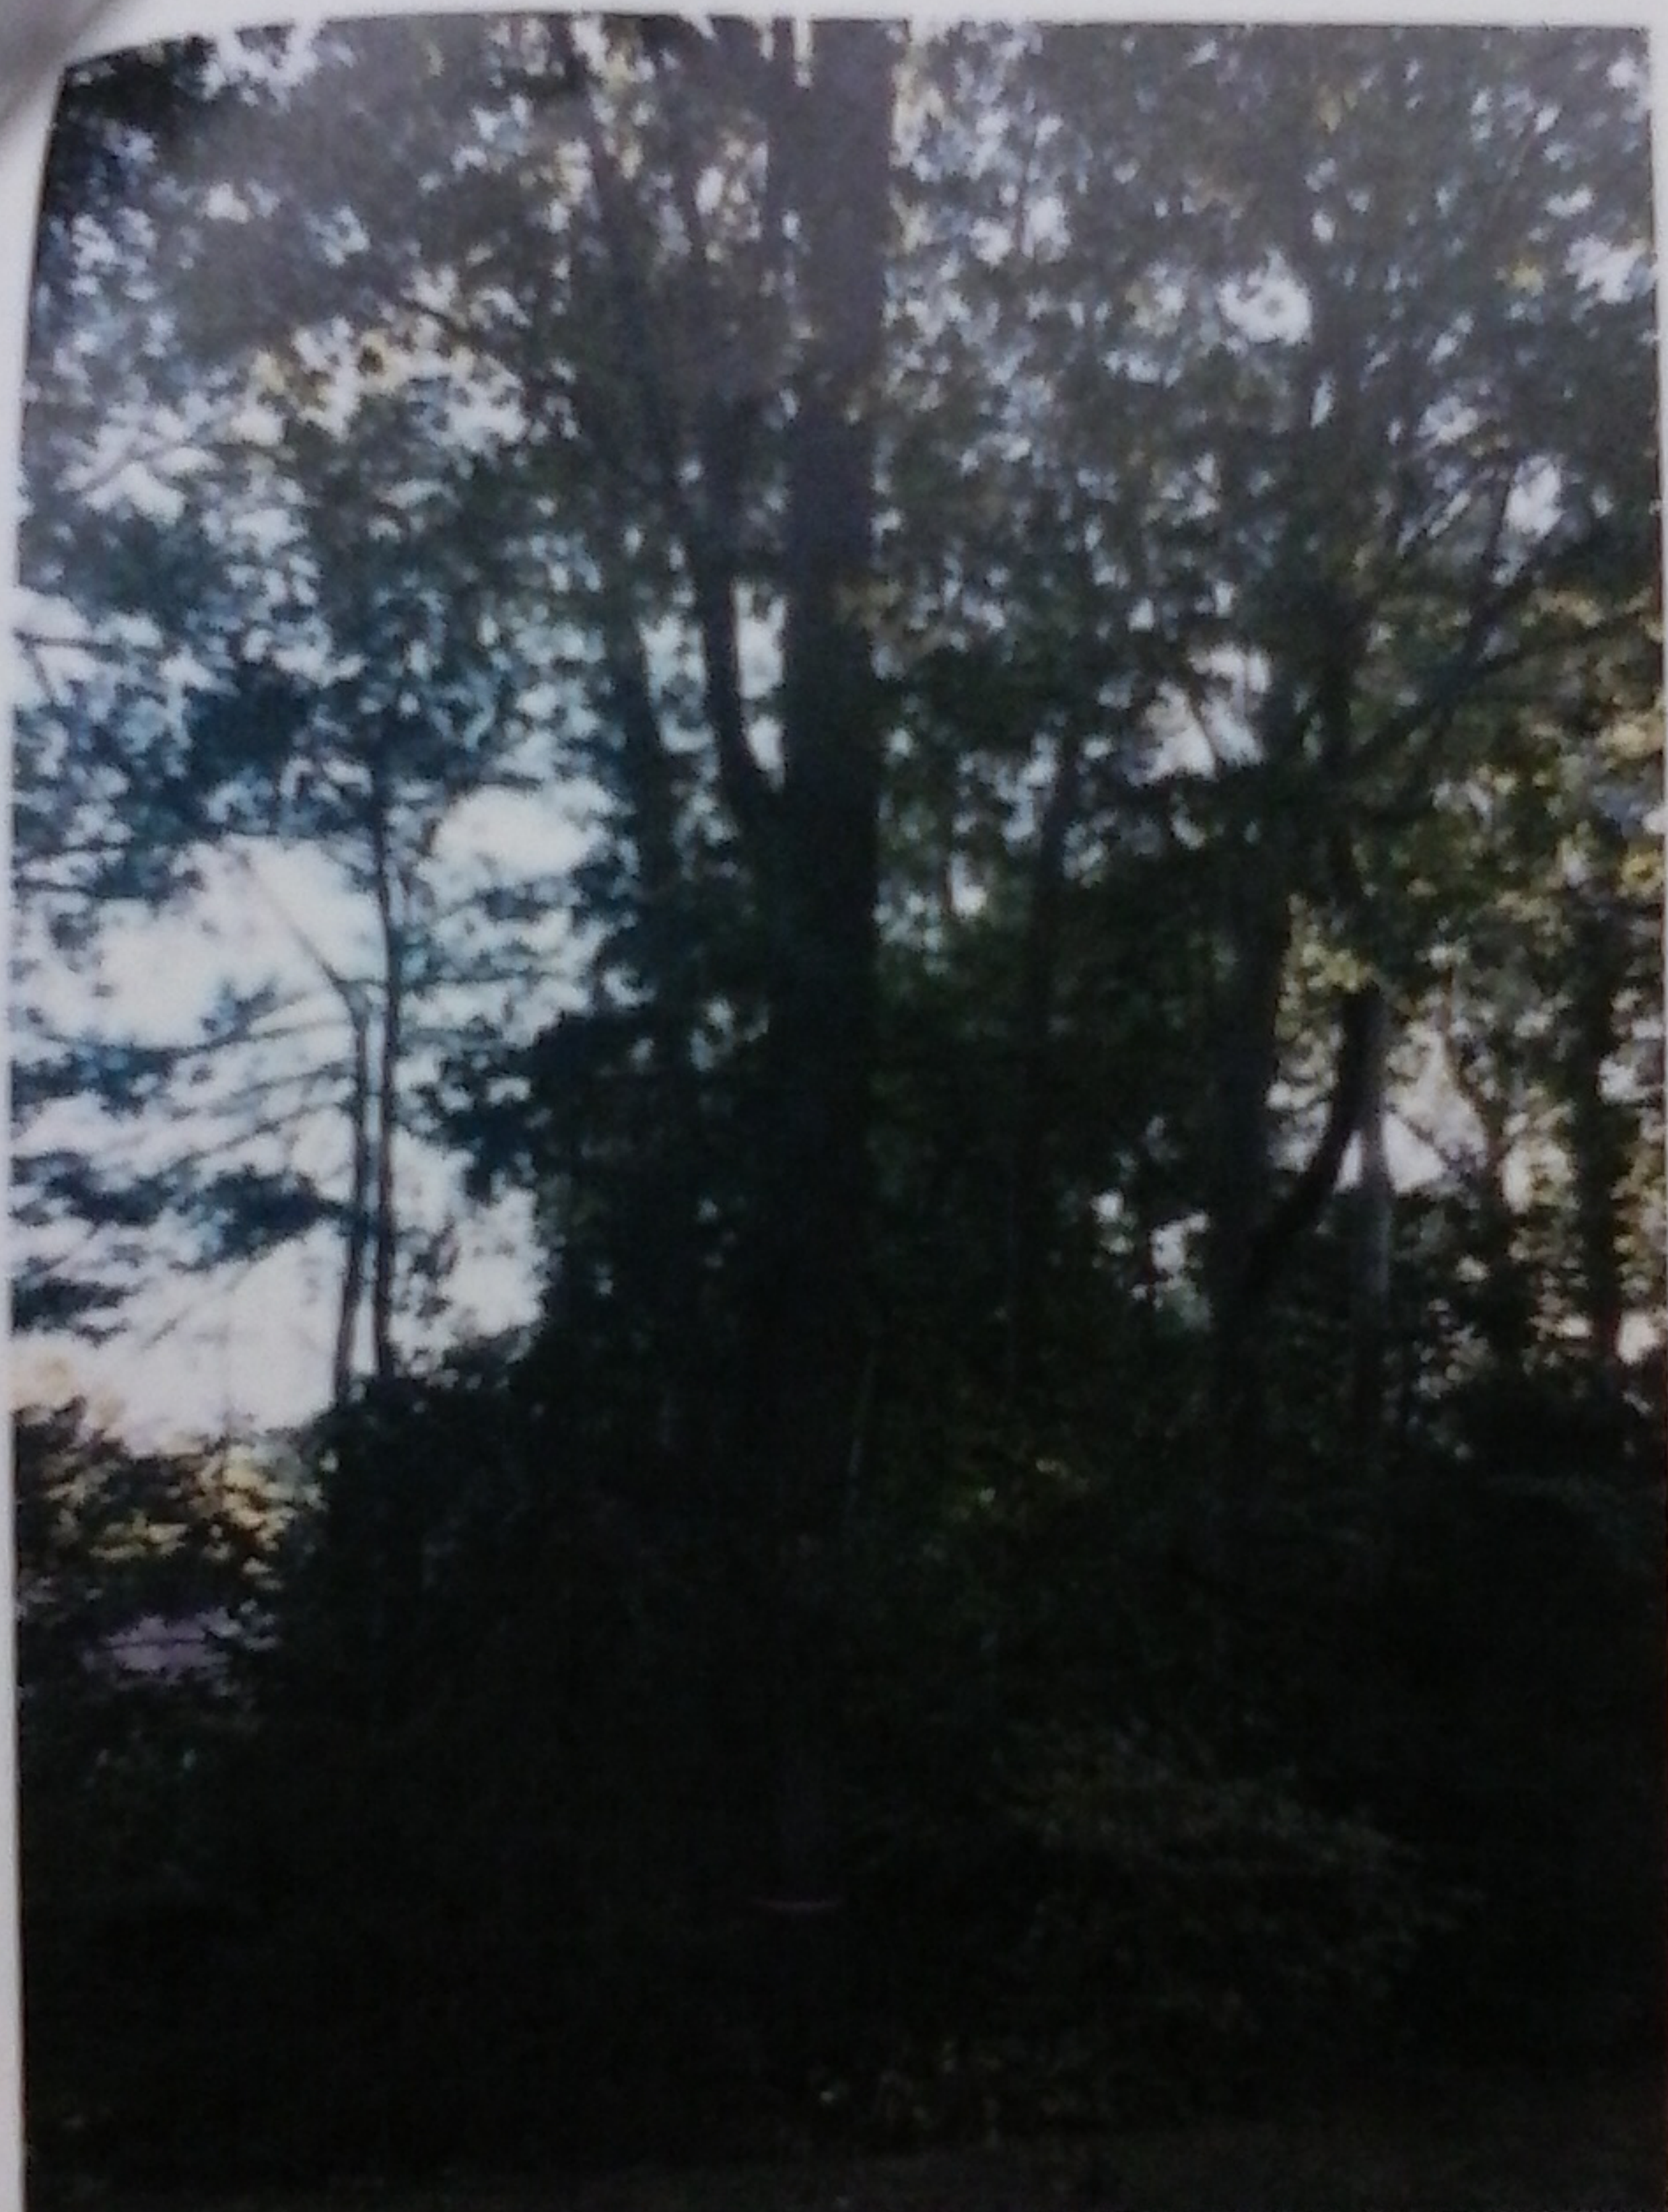
Tree 12 is an Oak in great condition located in the middle of back yard.

Oak tree 12 in good shape
