3/7/16 ARB 14 PEACOCK DR comid to 4-4-16 mtg

14 Peacock Drive, East Hills, NY 11576 Charles and Kimberly Perez

RE: Tree Inspection of 14 Peacock Drive East Hills, NY 11576

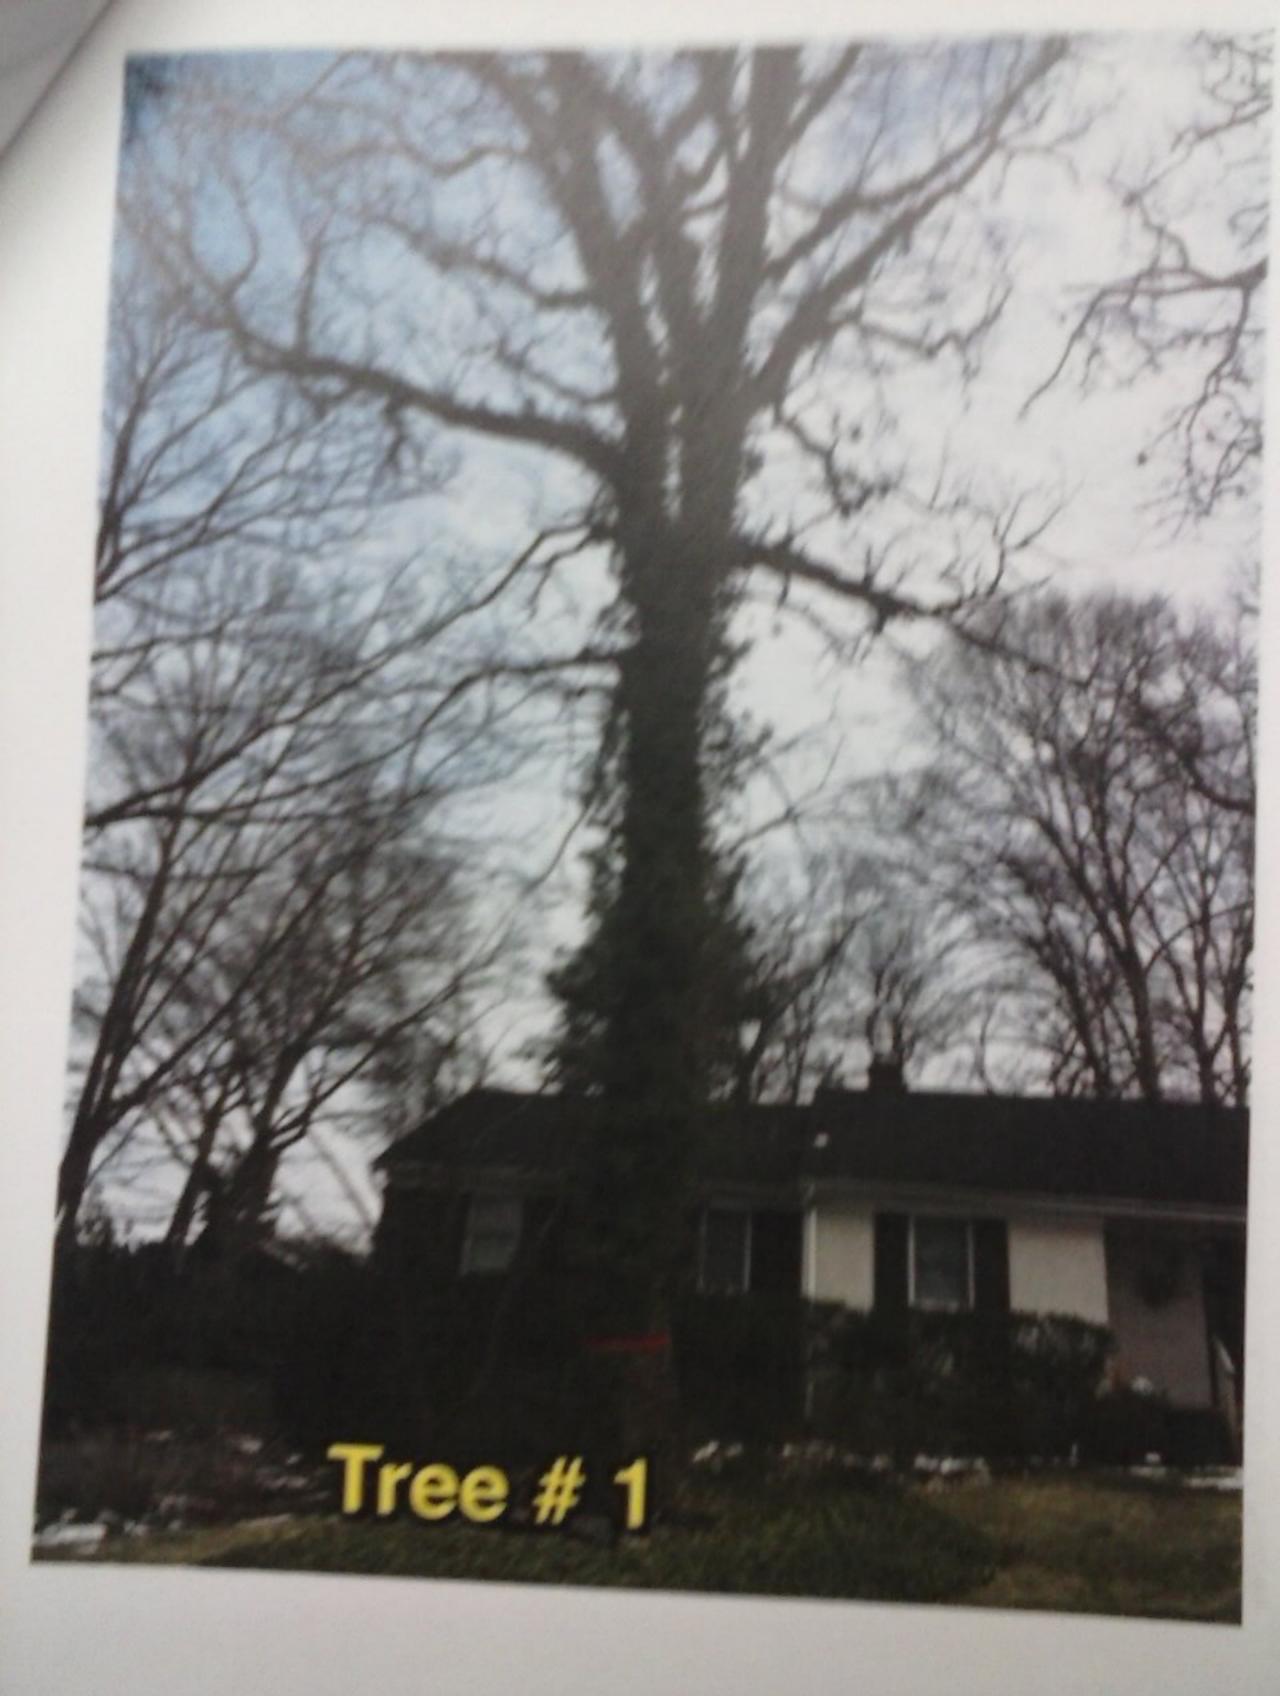
Tree number 1 is an oak growing in a well. It is in poor shape and the trunk is hollow. This tree should be removed.

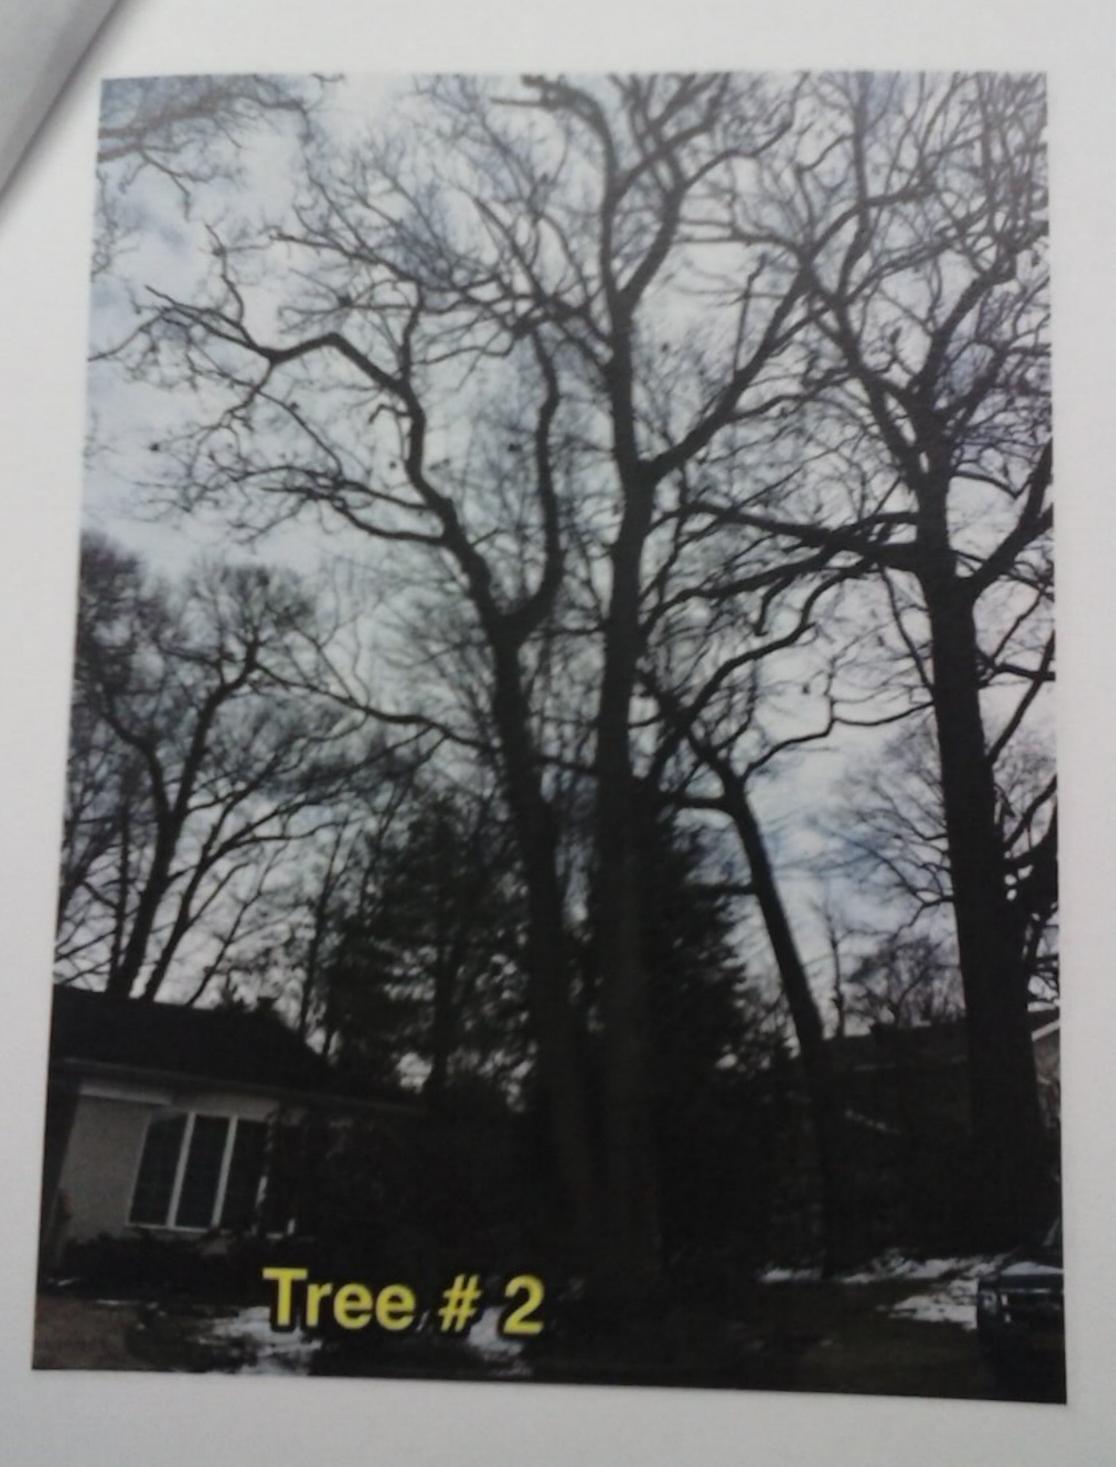
Tree number 2 is an oak in poor health. It has trunk defects and should be removed.

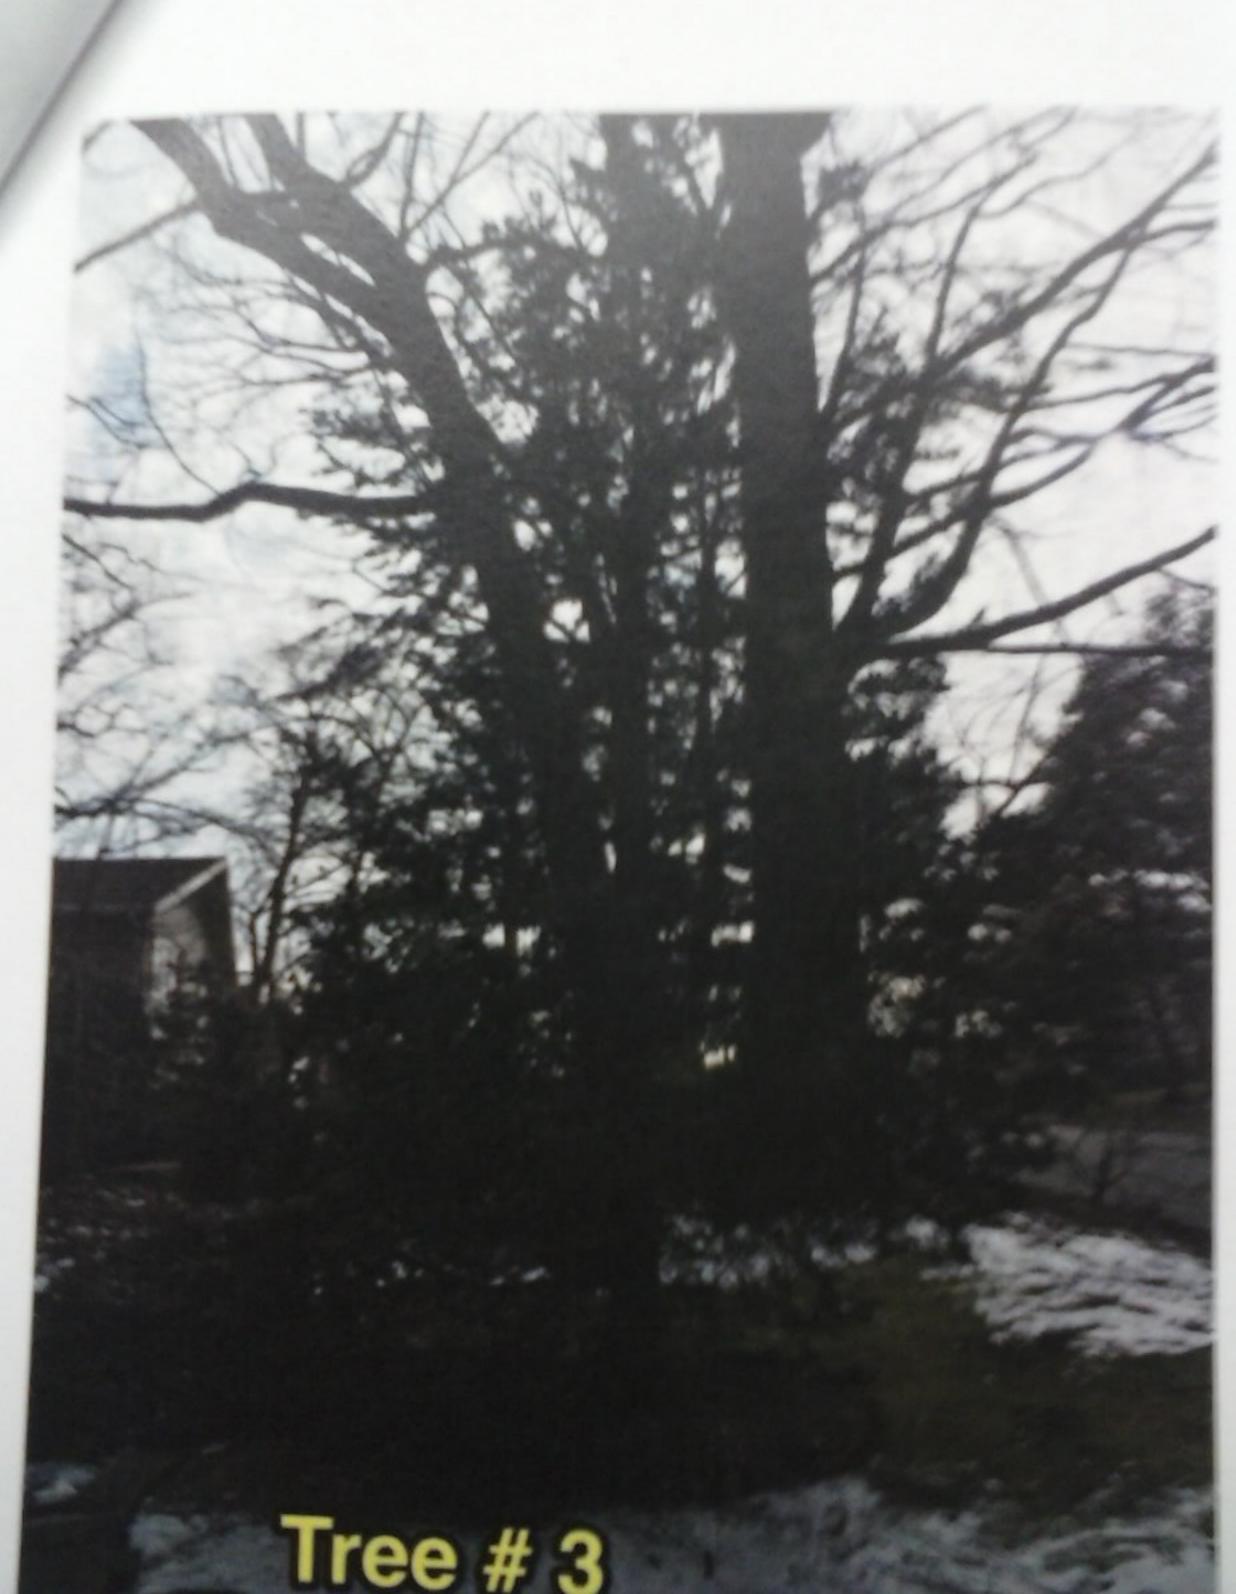
Tree number 3 is a Hanoki cypress in good health. It can remain.

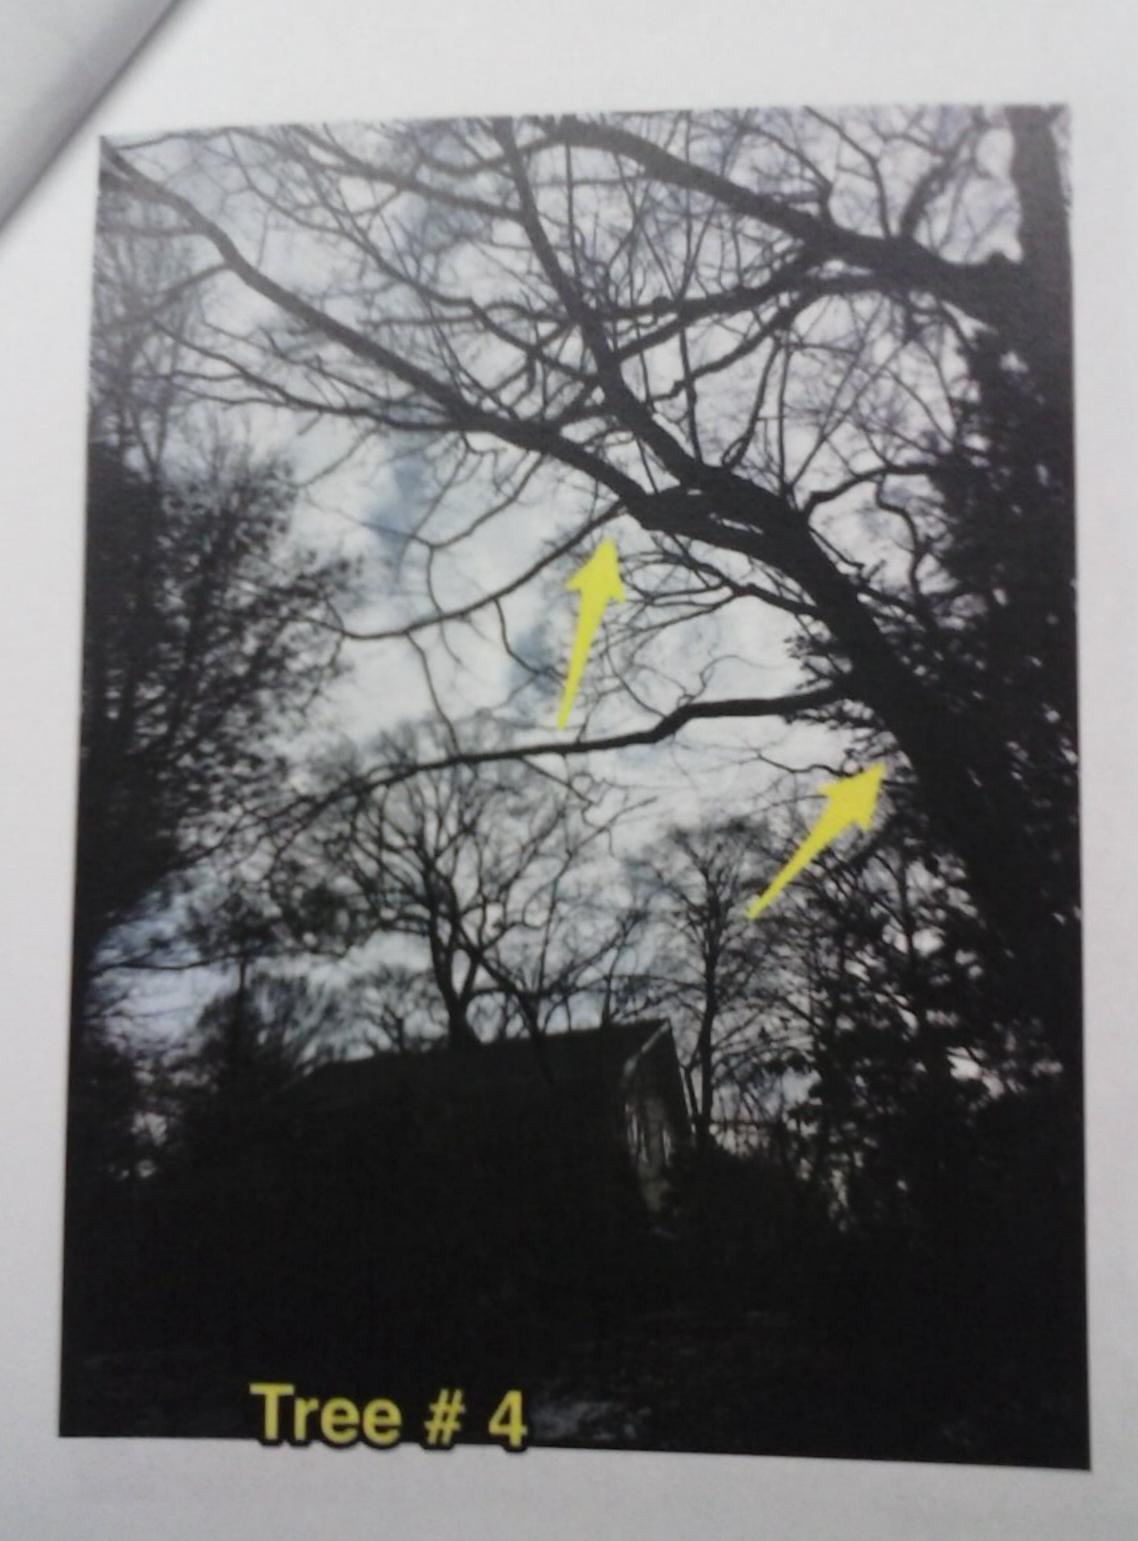
Tree number 4 is a leaning oak tree. It leans toward the house and is in poor health. This tree can be removed.

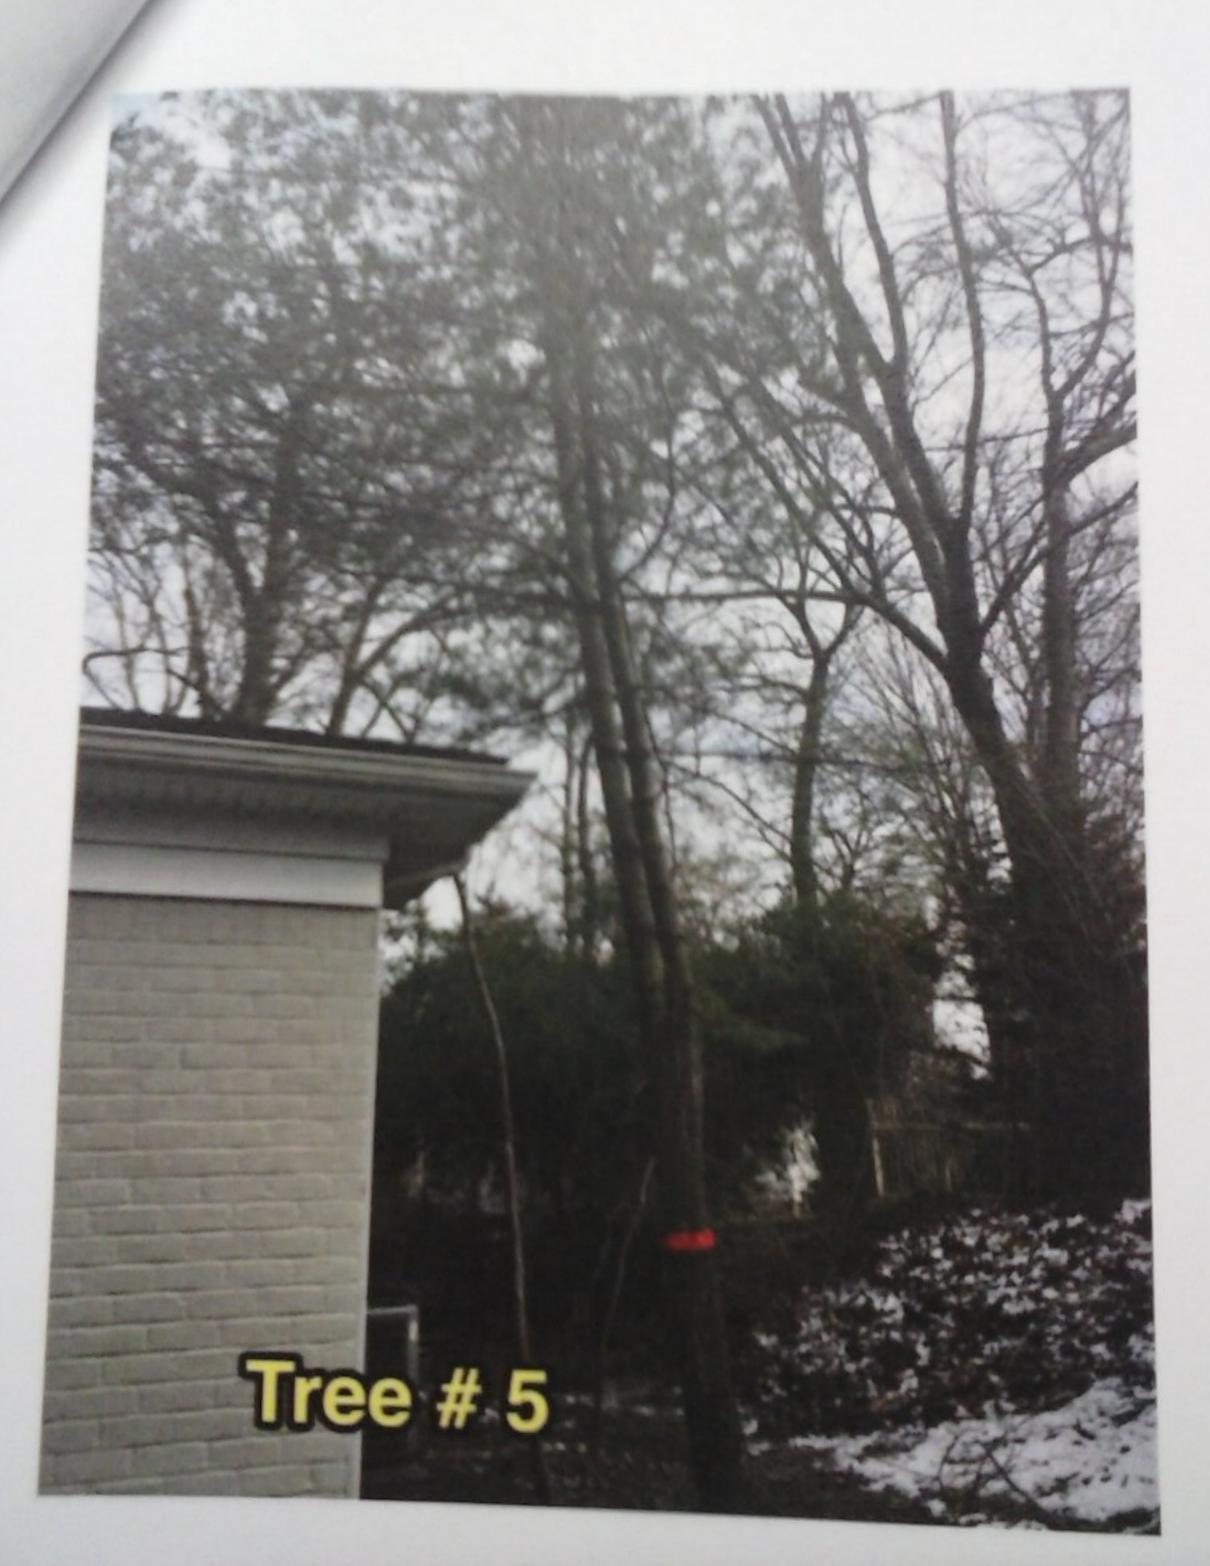
Tree number 5 is a small white pine in poor health. It is too close to the house and can be removed.

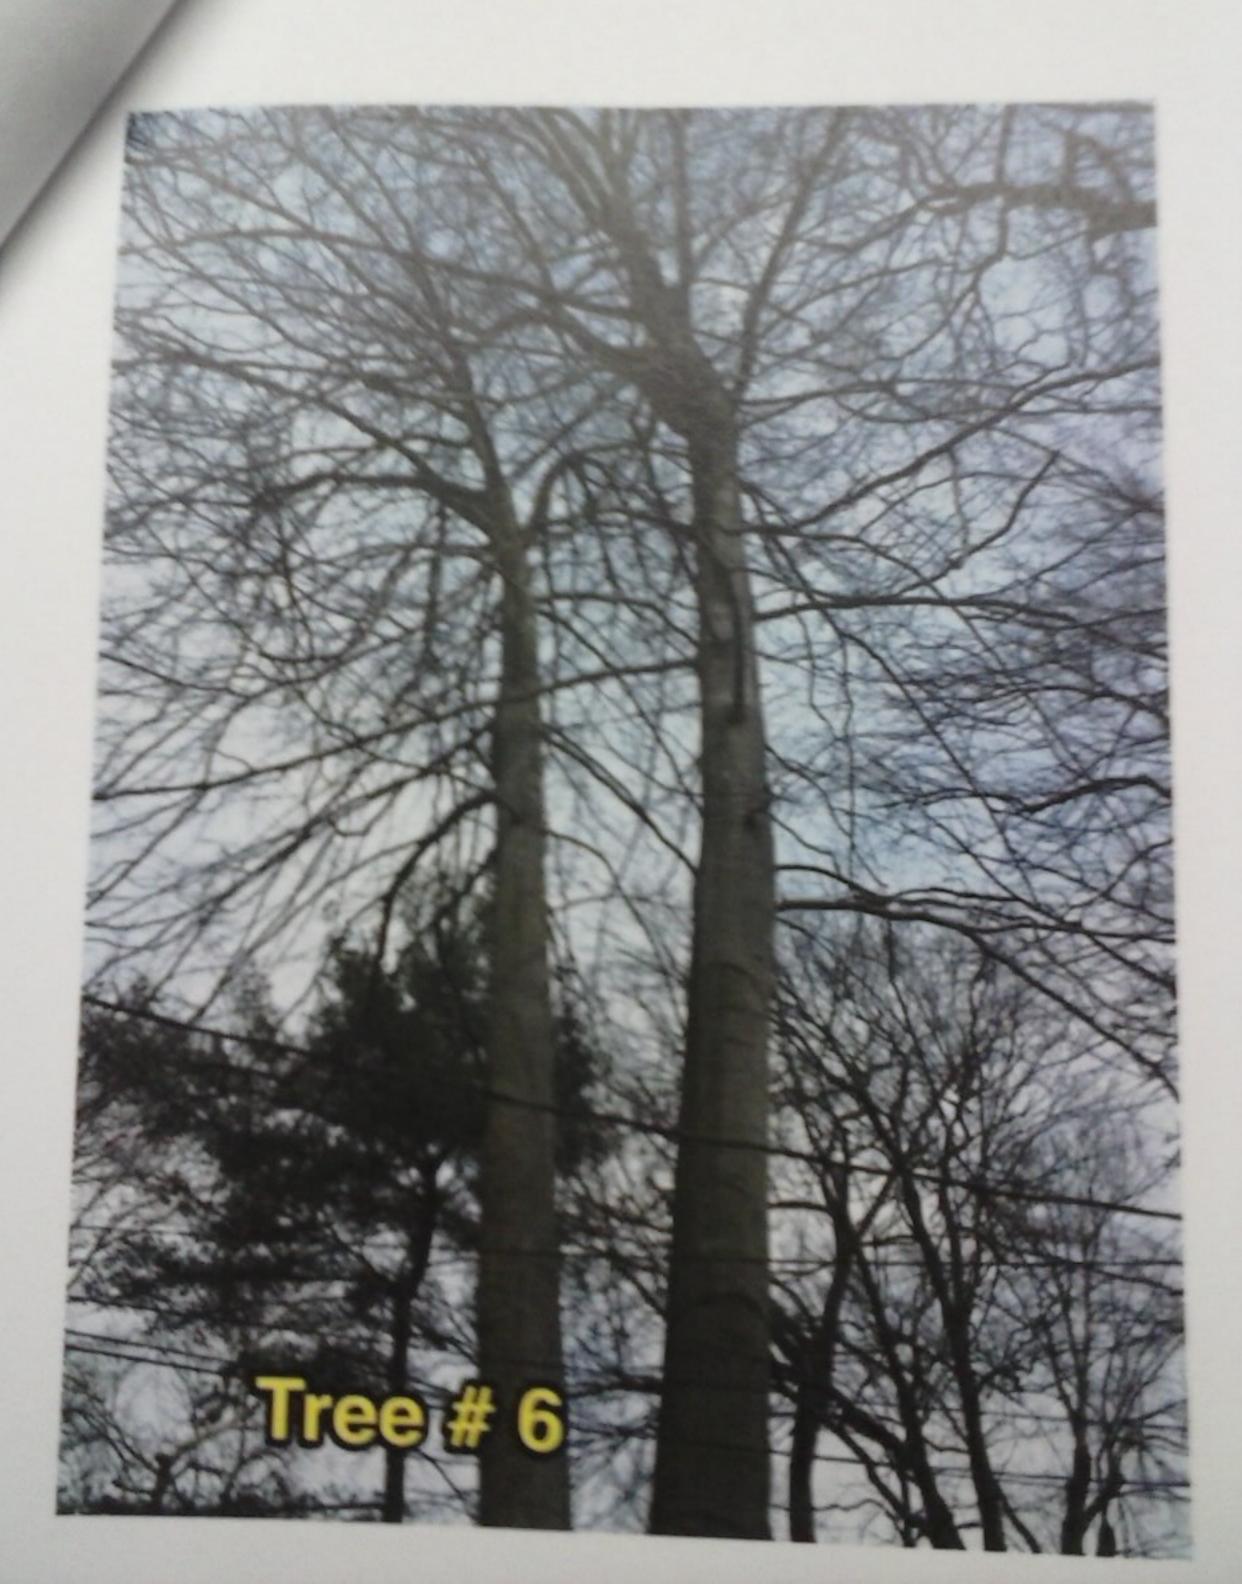
Tree number 6 is a beech tree in great health. There is no reason to remove this tree.

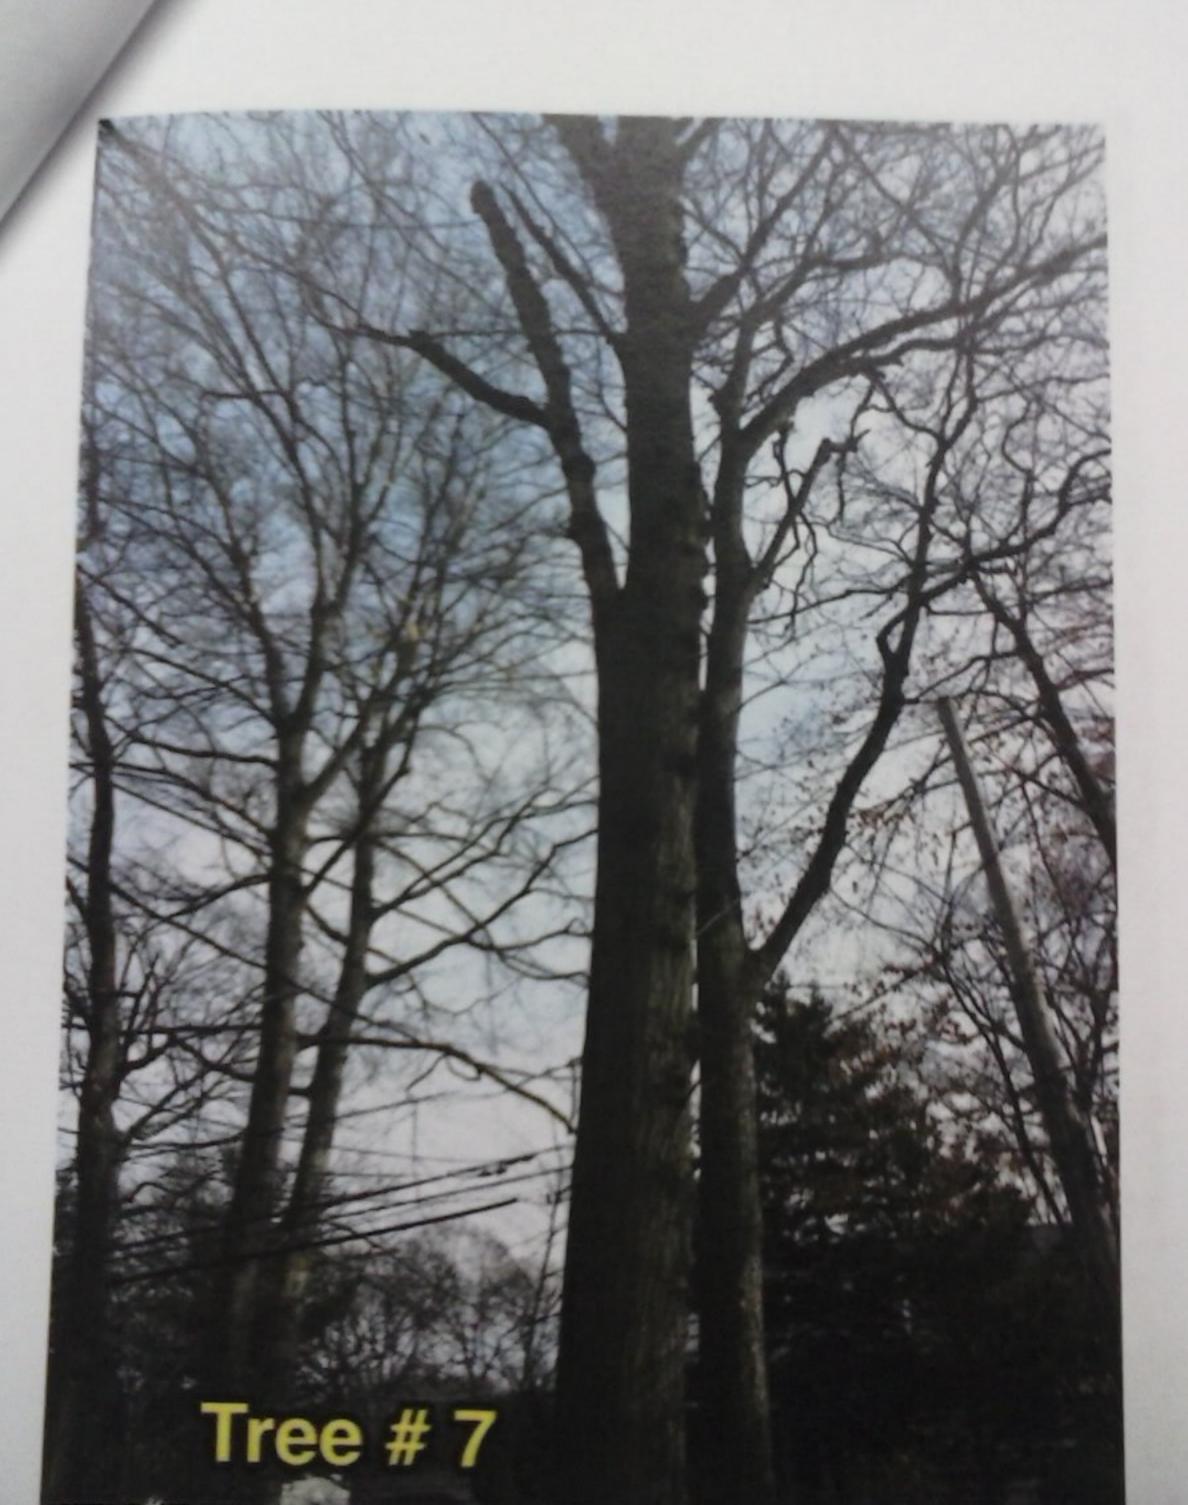
Tree number 7 is an oak tree. It has major trunk defects in its upper canopy. This tree can be removed.

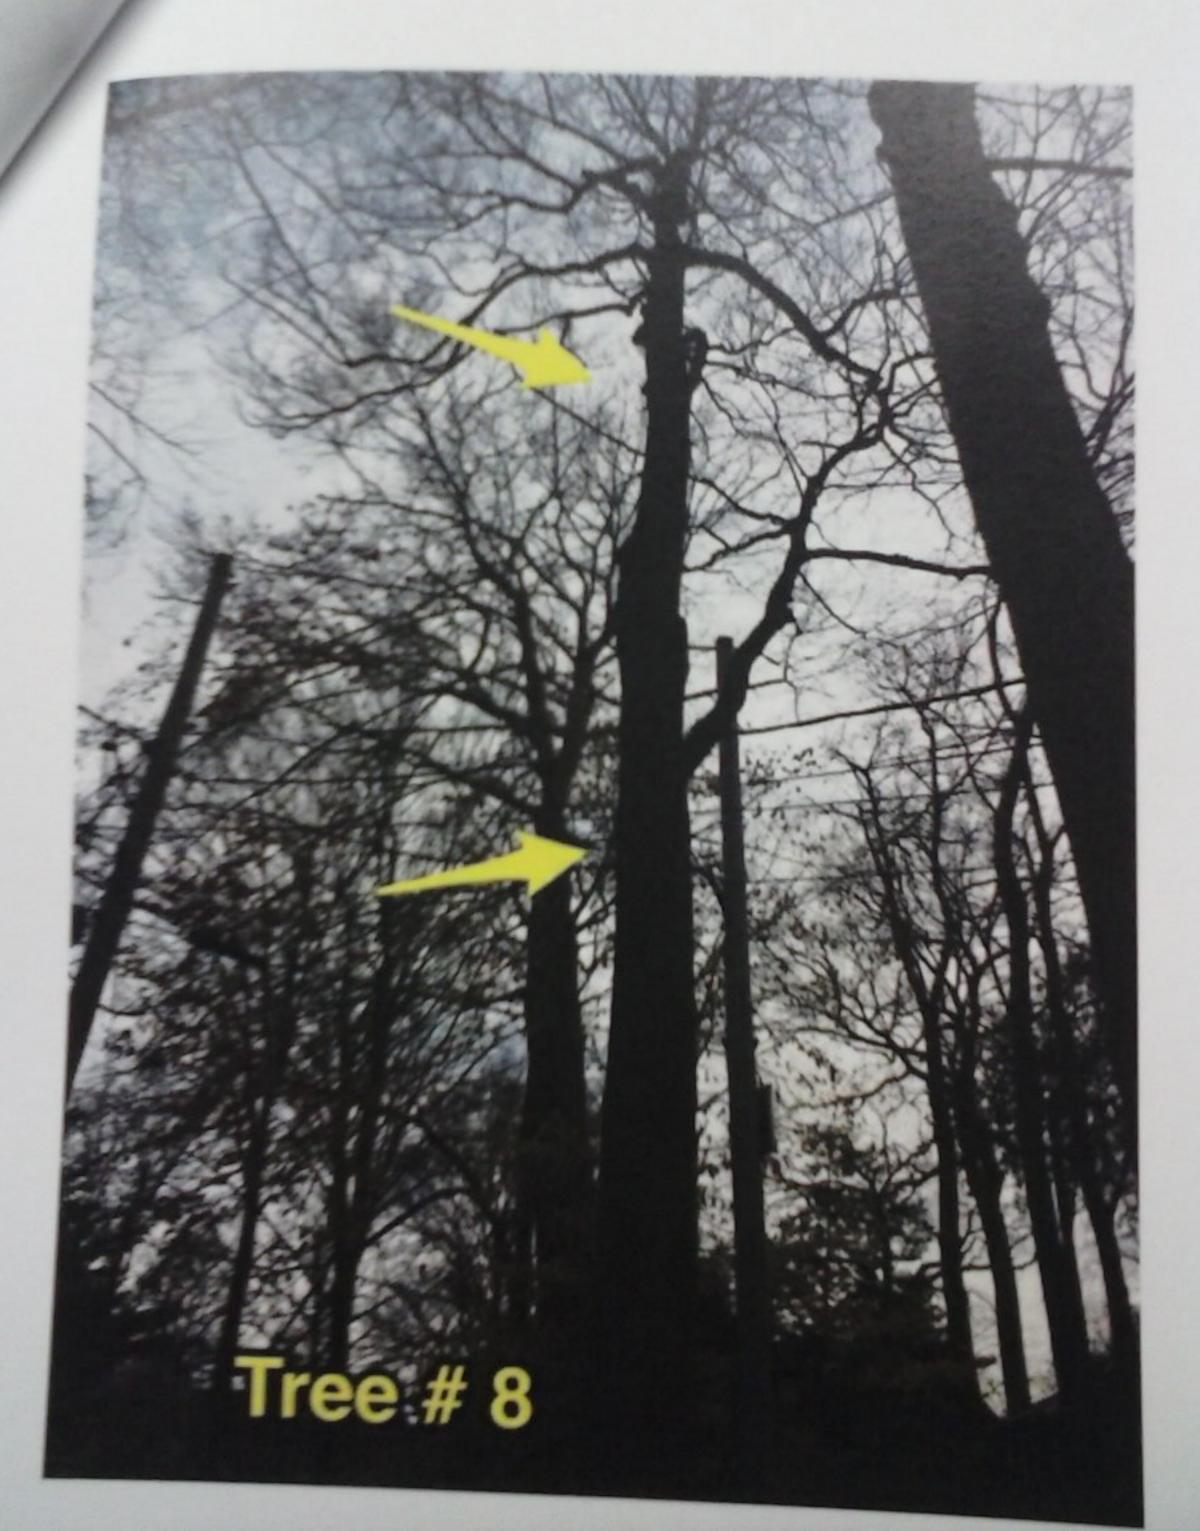
Tree number 8 is a black birch with major decay on its lower trunk. This tree can be removed.

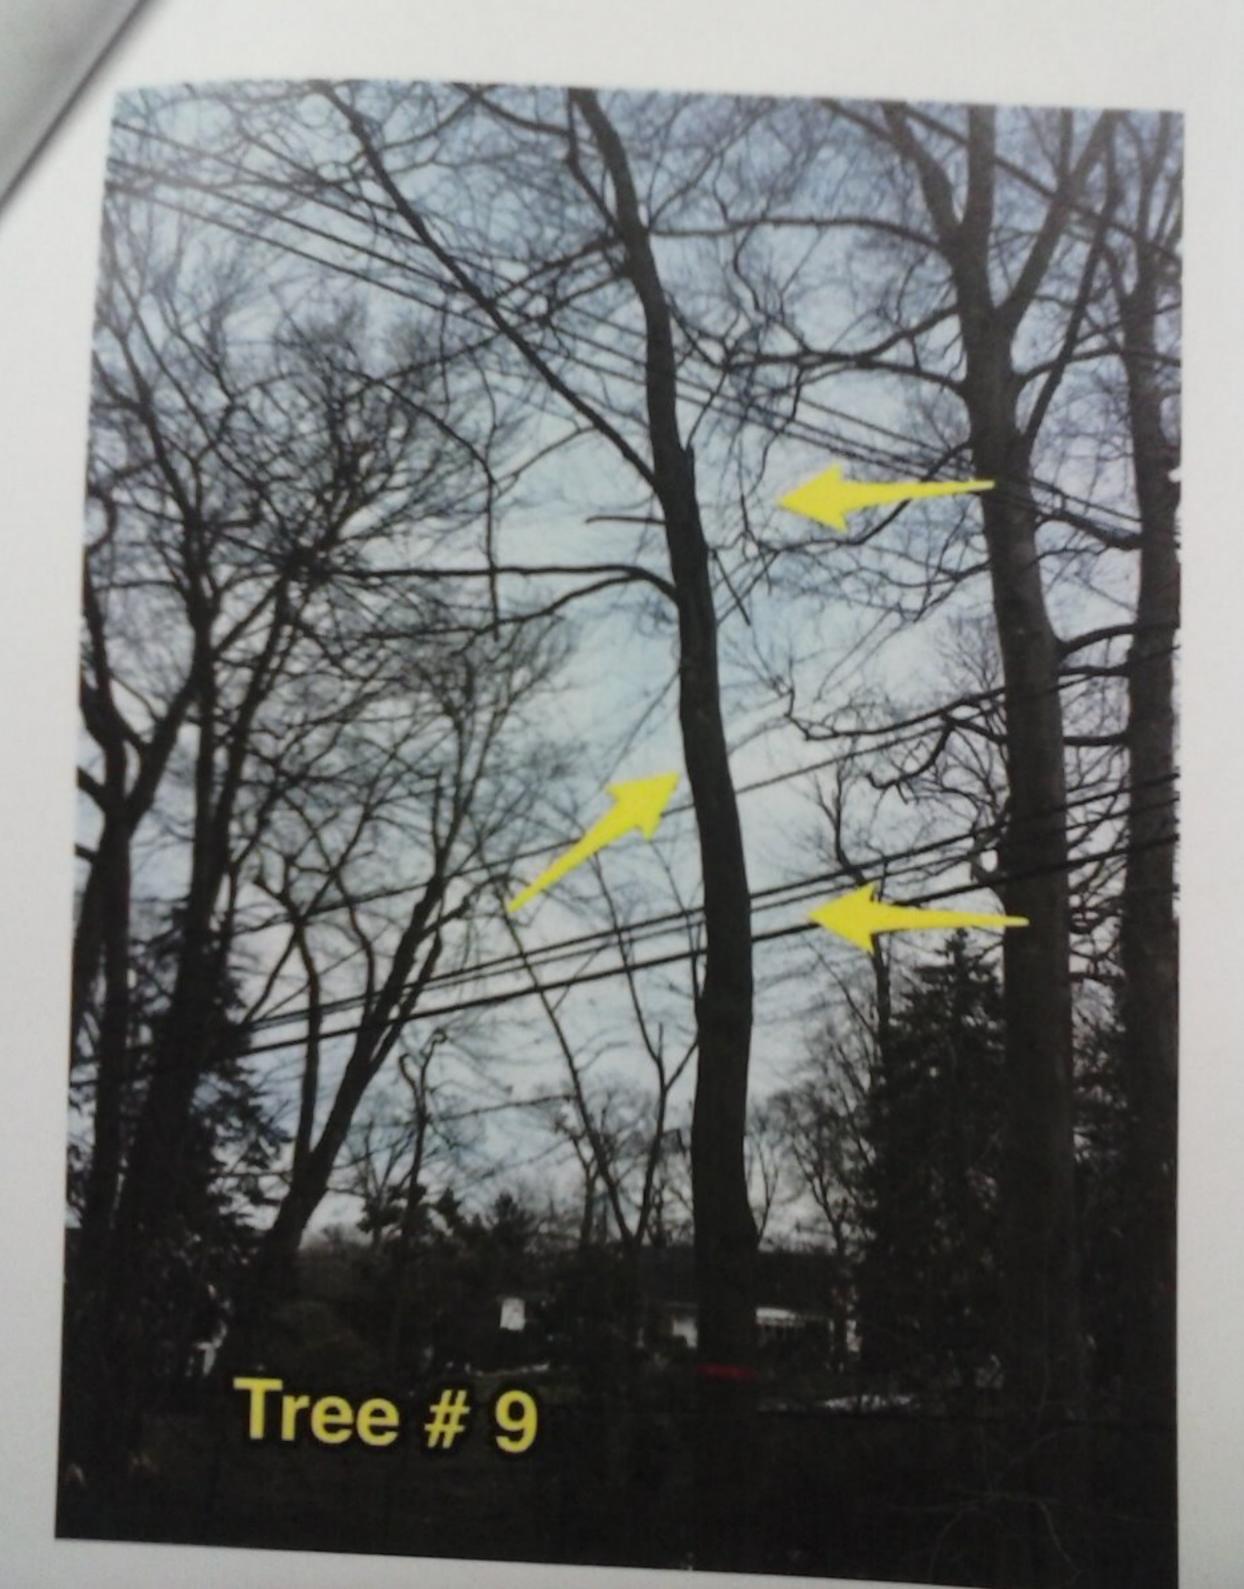
Tree number 9 is a maple with trunk decay and cavities. This tree should be removed.

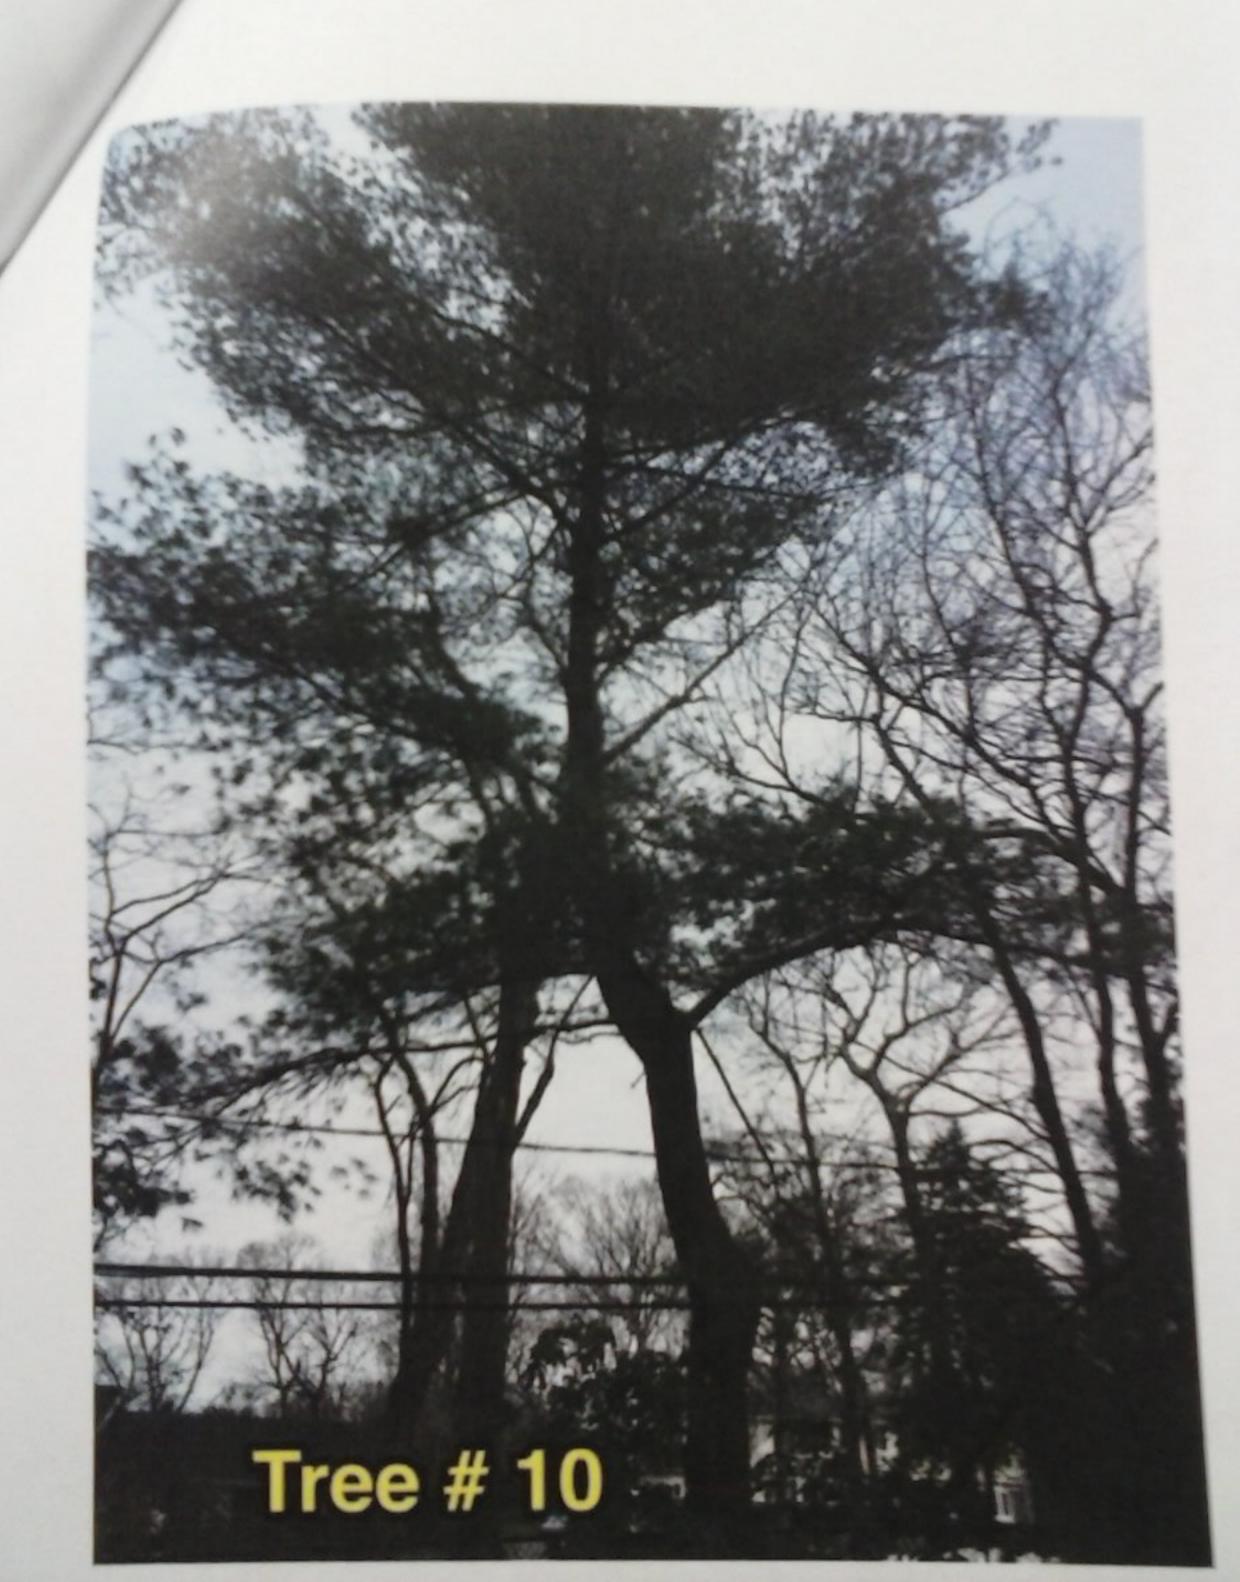
Tree number 10 is a white pine in good health. There is no reason to remove this tree.
