TREE HEALTH

RE: Tree Inspection of 185 Elm Drive East Hills, NY 11576

**TREE REMOVAL/ALTERATION PERMIT
APPLICATION**

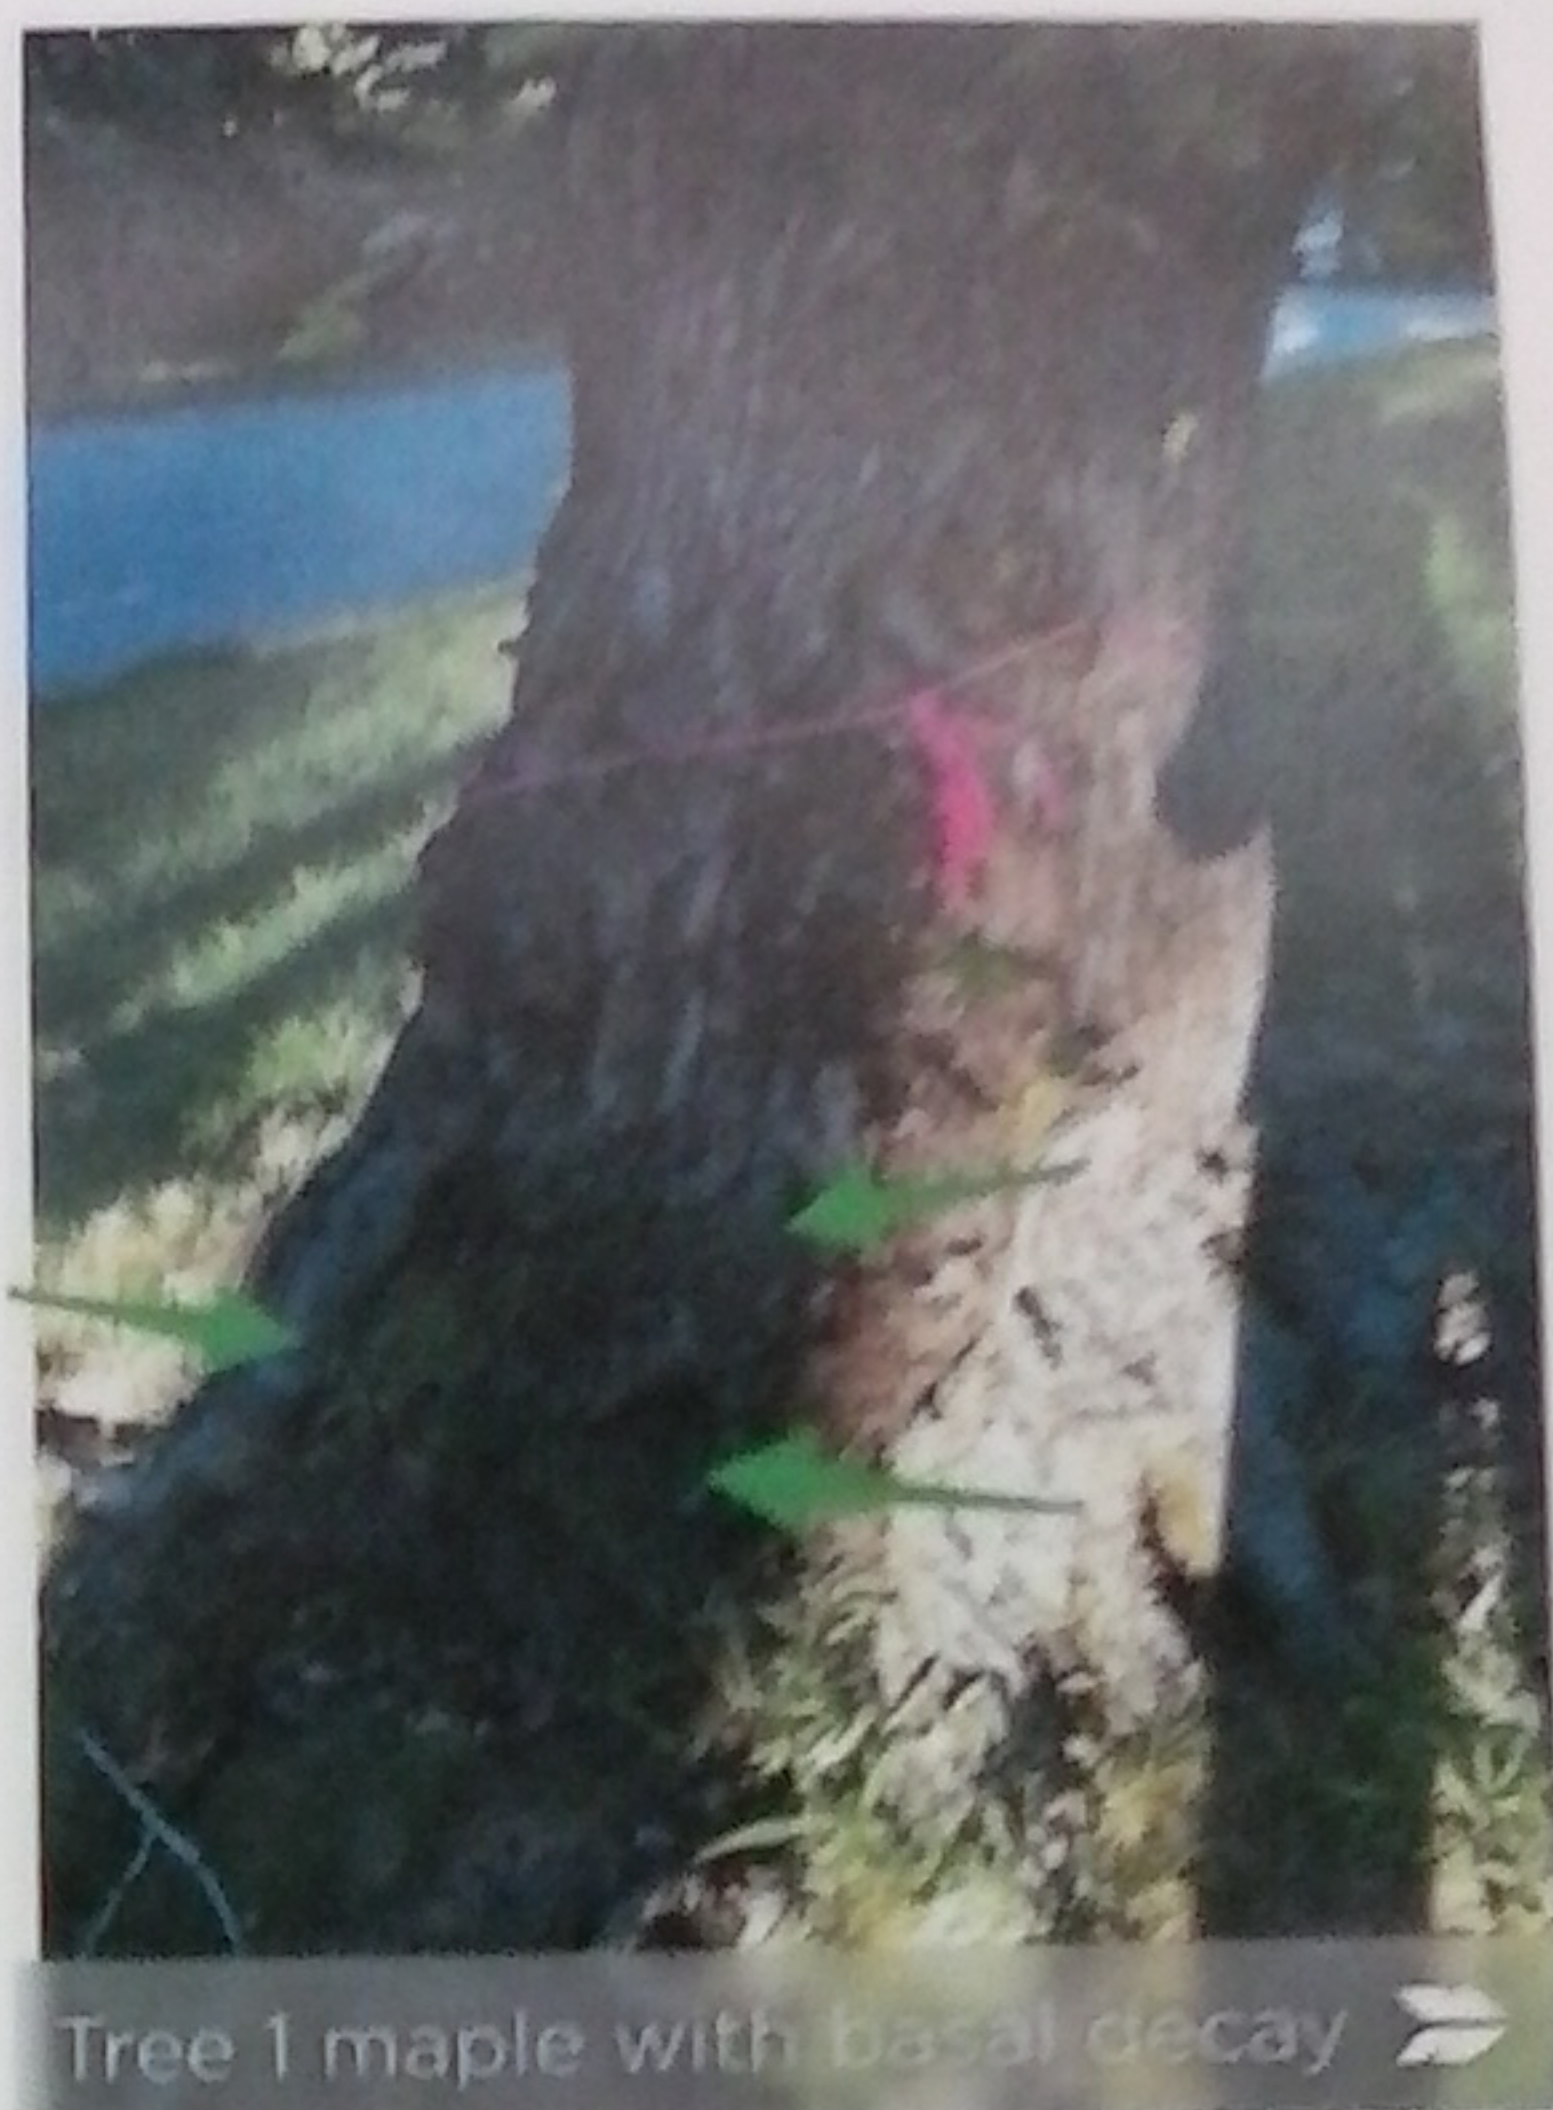
Tree 2 is a large Oak on the east side of the house. The tree is in good health but is located 8 feet from the house. I can't determine if its roots are impacting the foundation from this perspective (I would need to see inside).

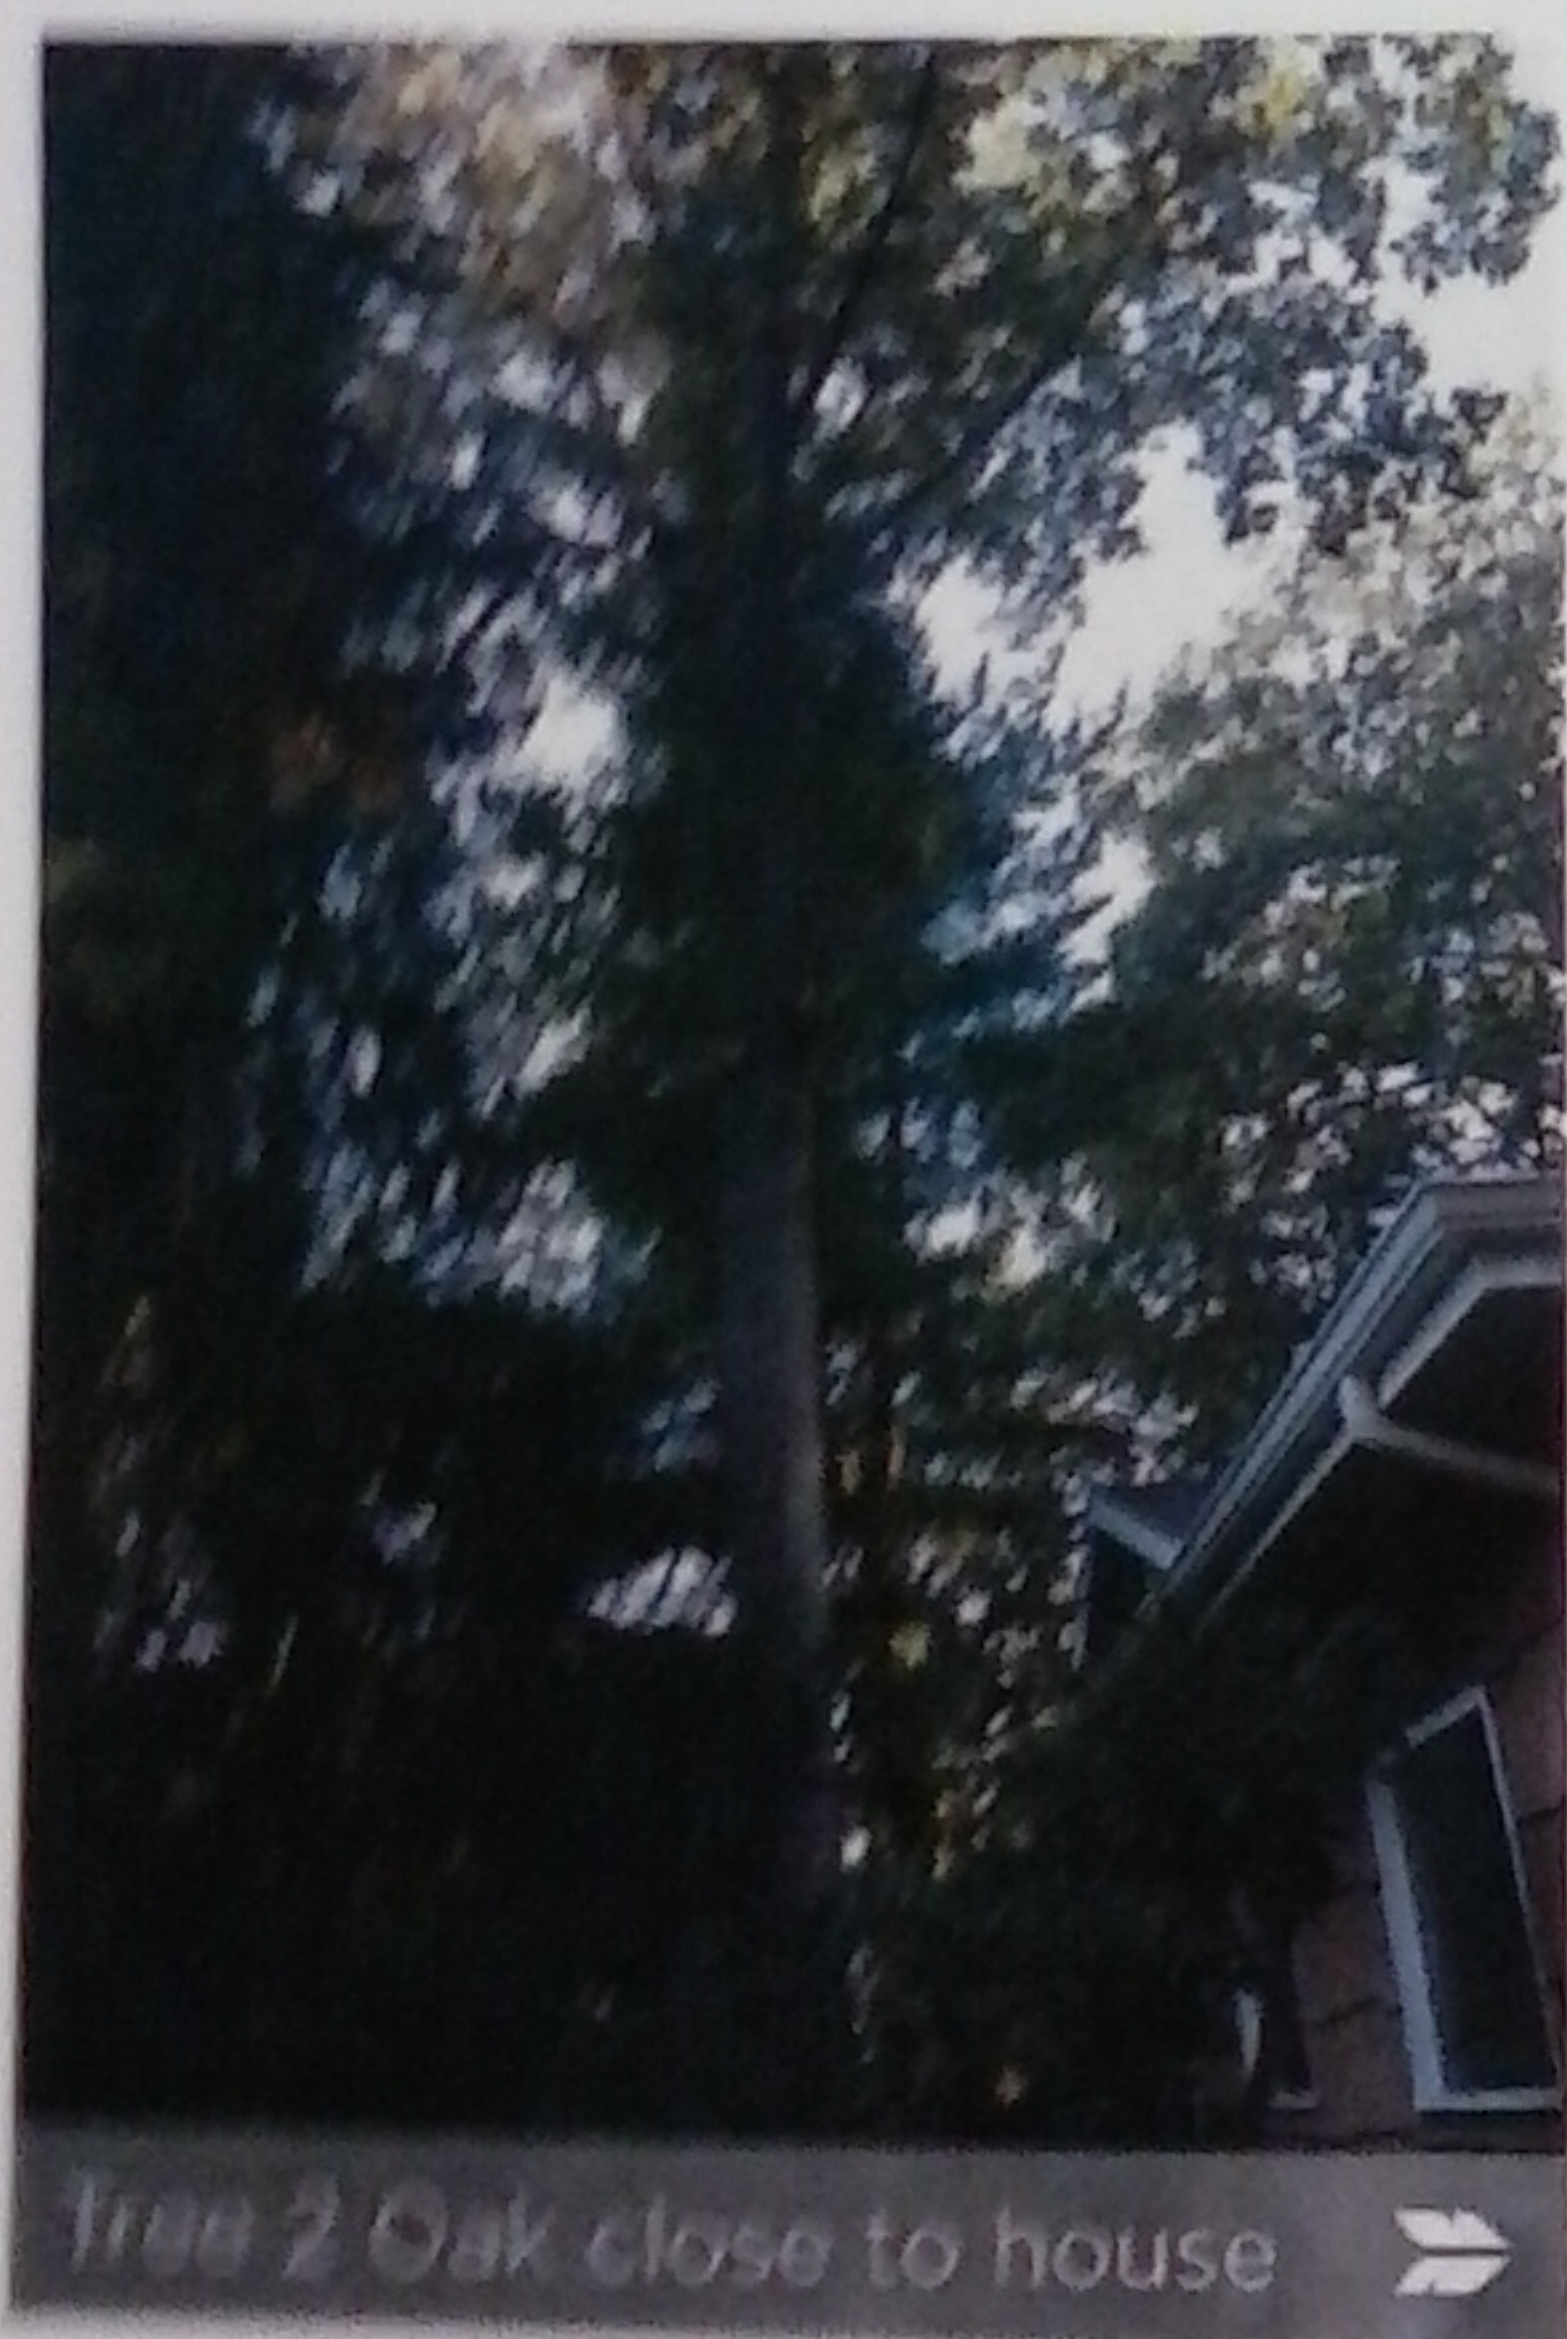
Tree 3 is a white Pine also close to the house. This tree has a lean and it has a misbalanced cavity. Its roots have cracked the patio.

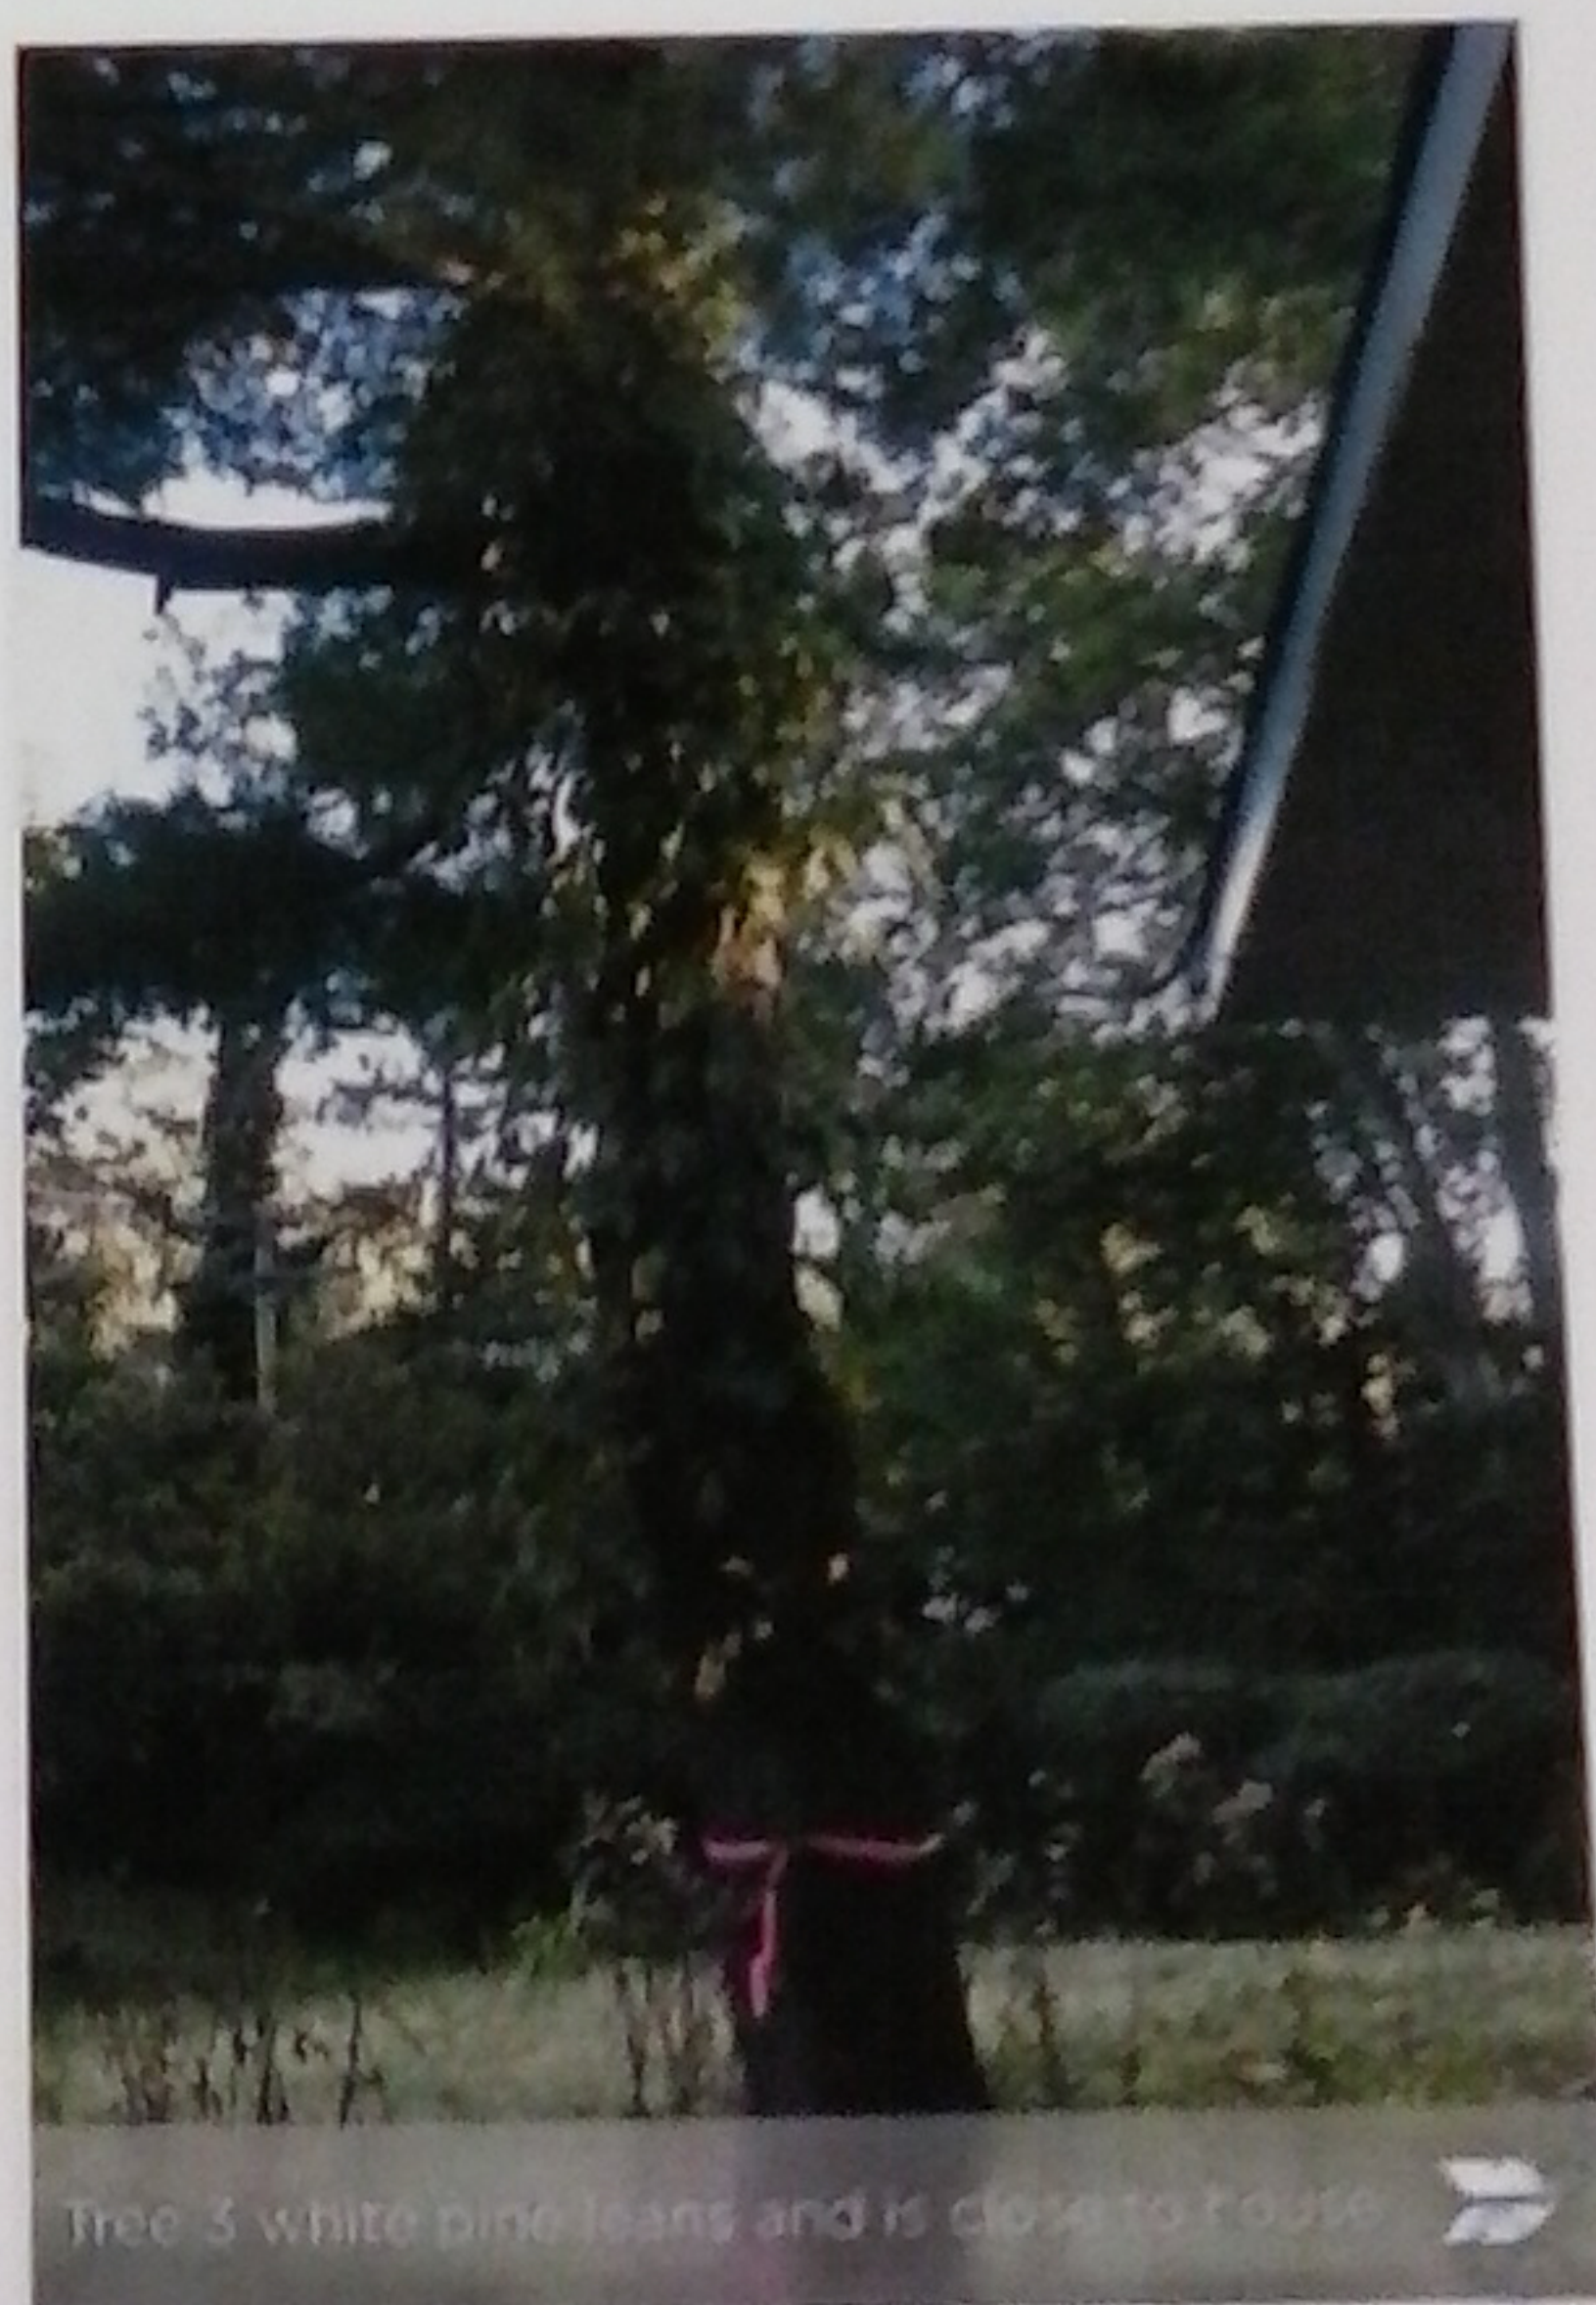
Tree number 5 is a Beech tree in moderate health that leans toward the house. This tree can become susceptible to failure after tree number 6 is removed.
